Hello! Good morning, and Welcome to our 2023 convention!

My goal today is to discuss the accidents that have occurred since our Tucson Convention last year, and then try to put them into the larger context of MMOPA's mission of improving safety.

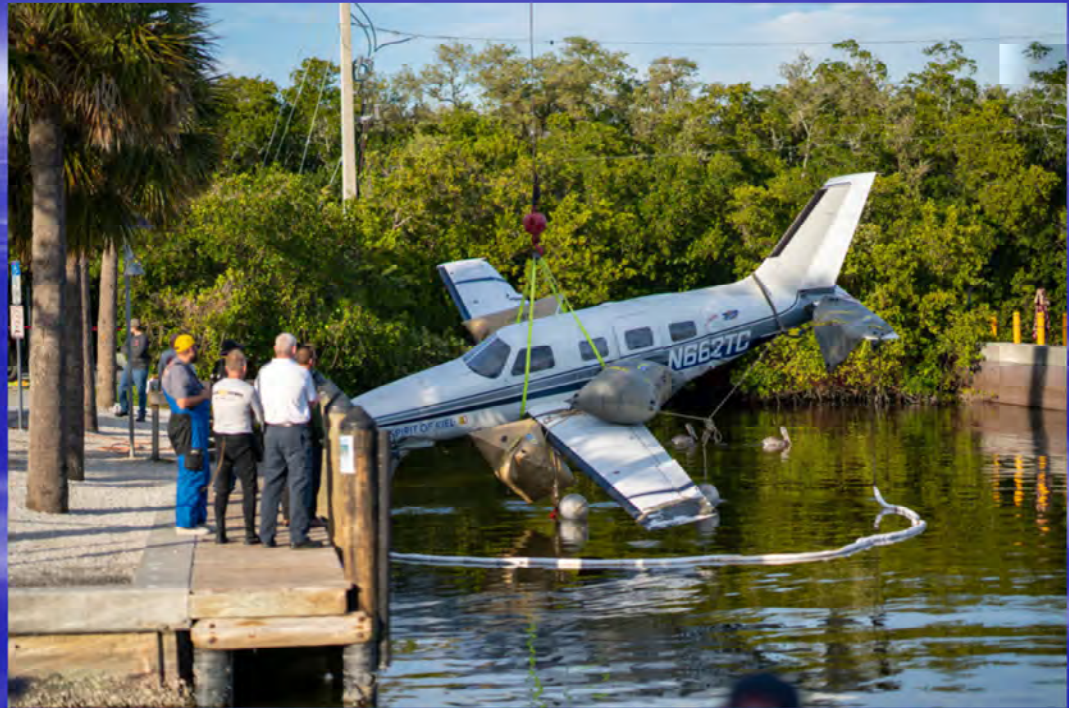
N662TC

The plane was recovered from the shallow water.

And the final NTSB report reveals the cause of the engine power loss.

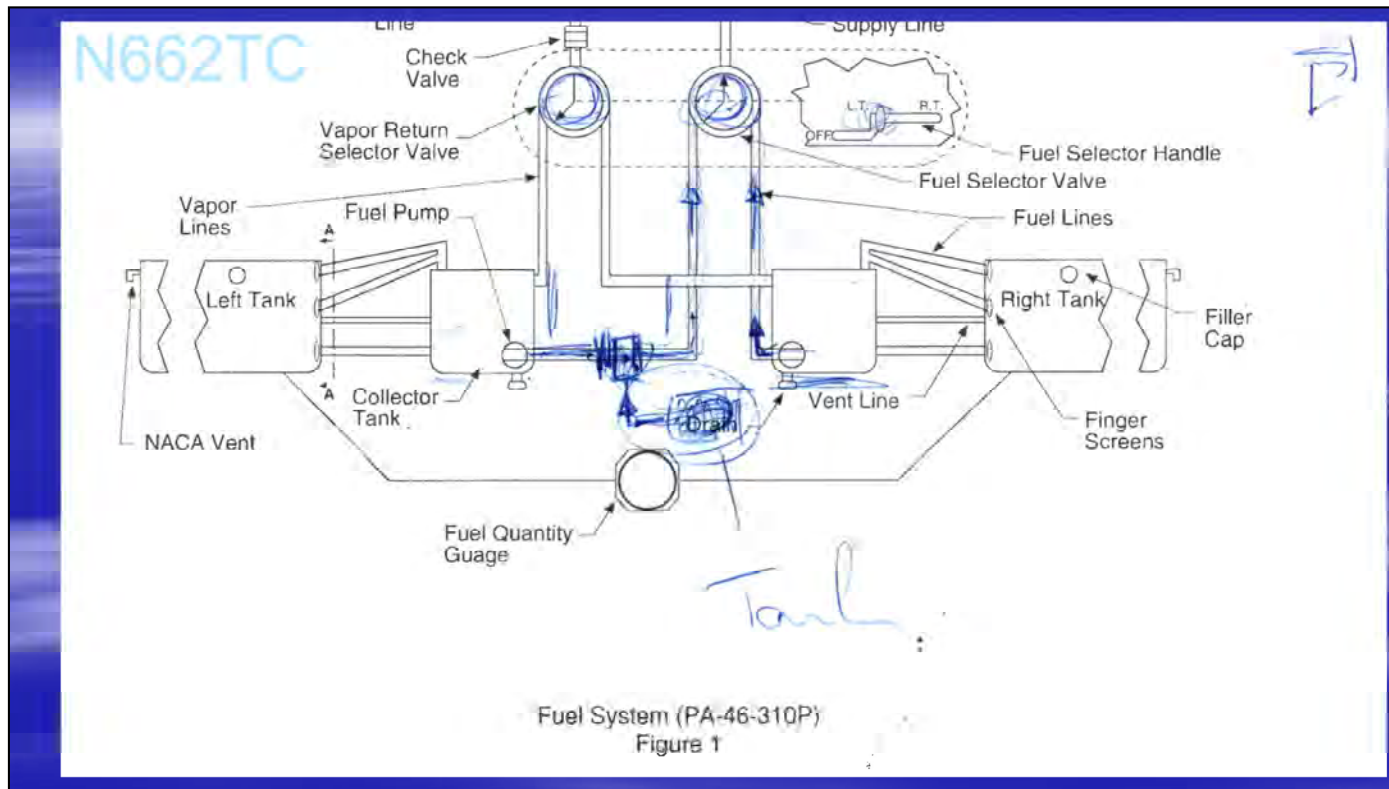
This diagram is the only documentation in the airplane logs or POH regarding the ferry tank installation.

There was no STC or Form 337.

This is a good lesson for us to fully document airframe changes, as well as updating our checklists (in this case – the pre-start checklist and the engine failure checklist) to account for such modifications.

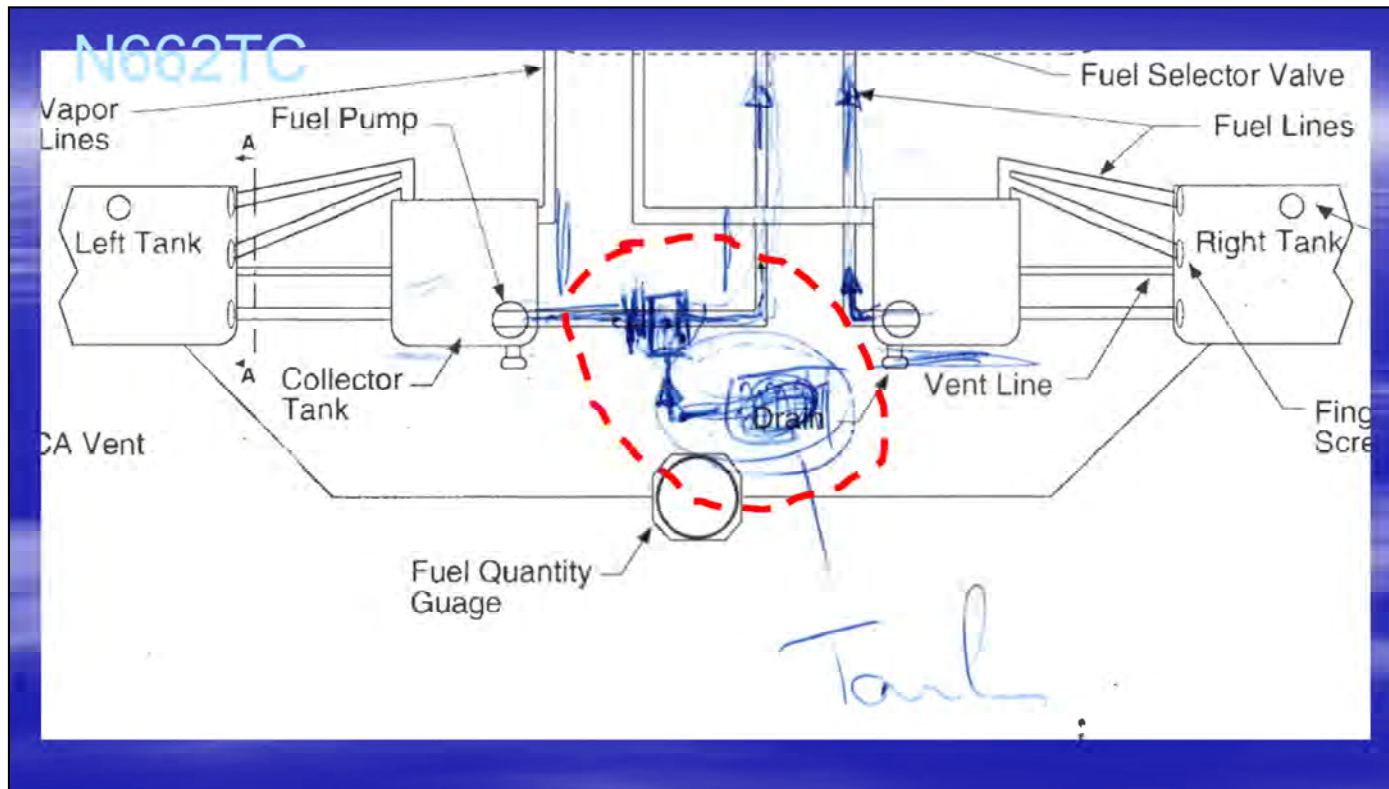
You can see the ferry tank was connected to the left tank fuel line.

With the valve in the "on" position, as it was found in the recovered plane and shown here, fuel flows from the ferry tank.

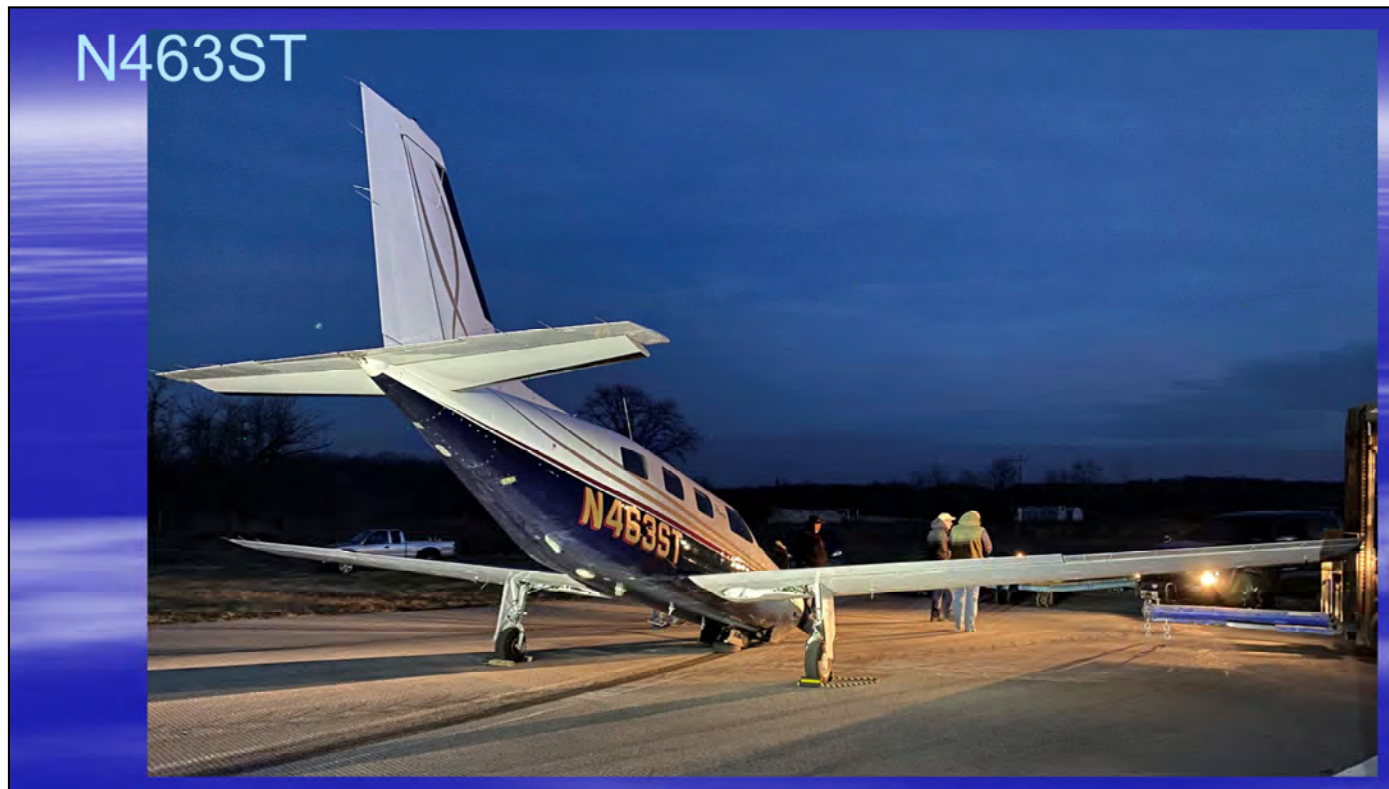
The local mechanic at the time said this seemed to be an actuator attachment point failure on the engine mount.

We saw a lot of these in the past, until Piper came out with a strengthened engine mount. We haven't seen much of these mount failures for at least a decade now.

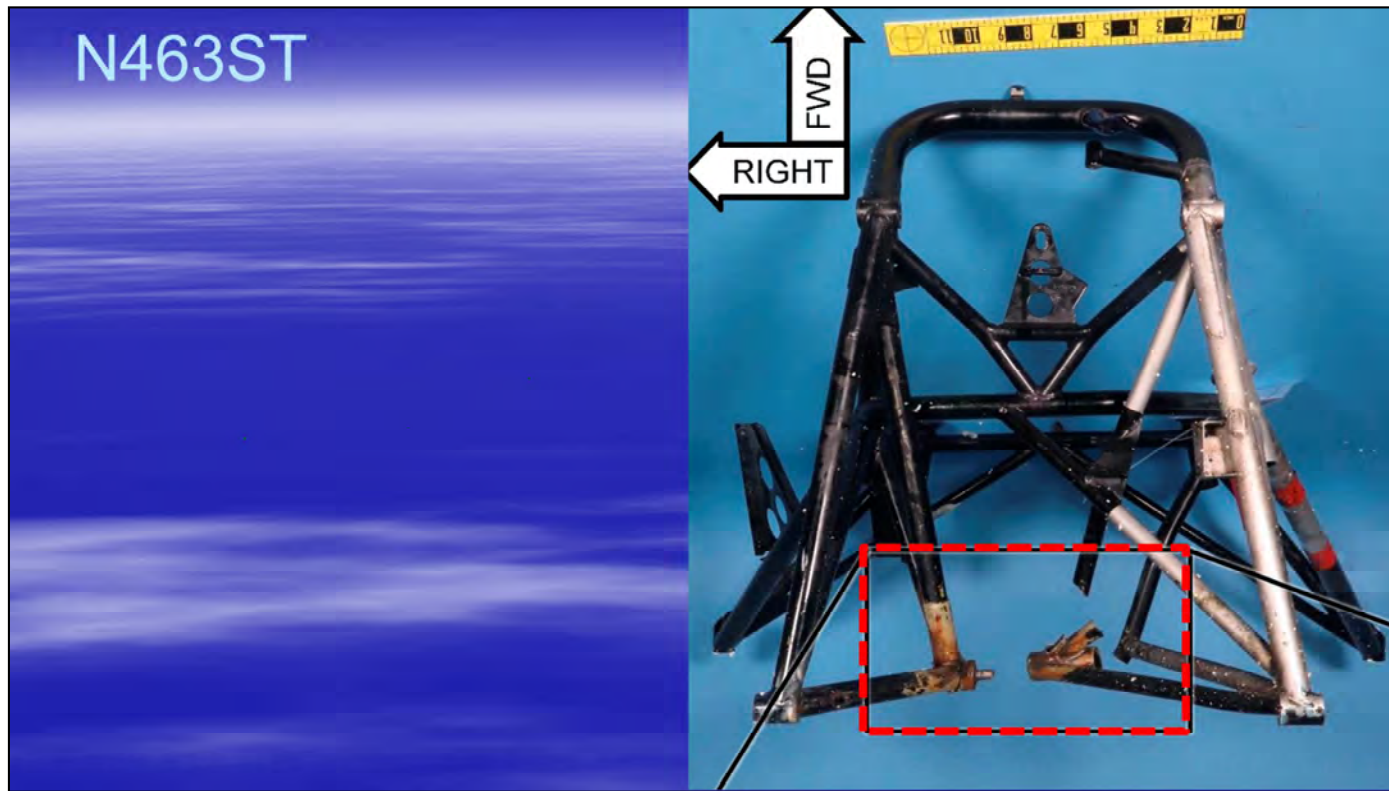
The engine mount was sent to the NTSB for examination, and is shown here, with the broken nose gear actuator attach point highlighted.

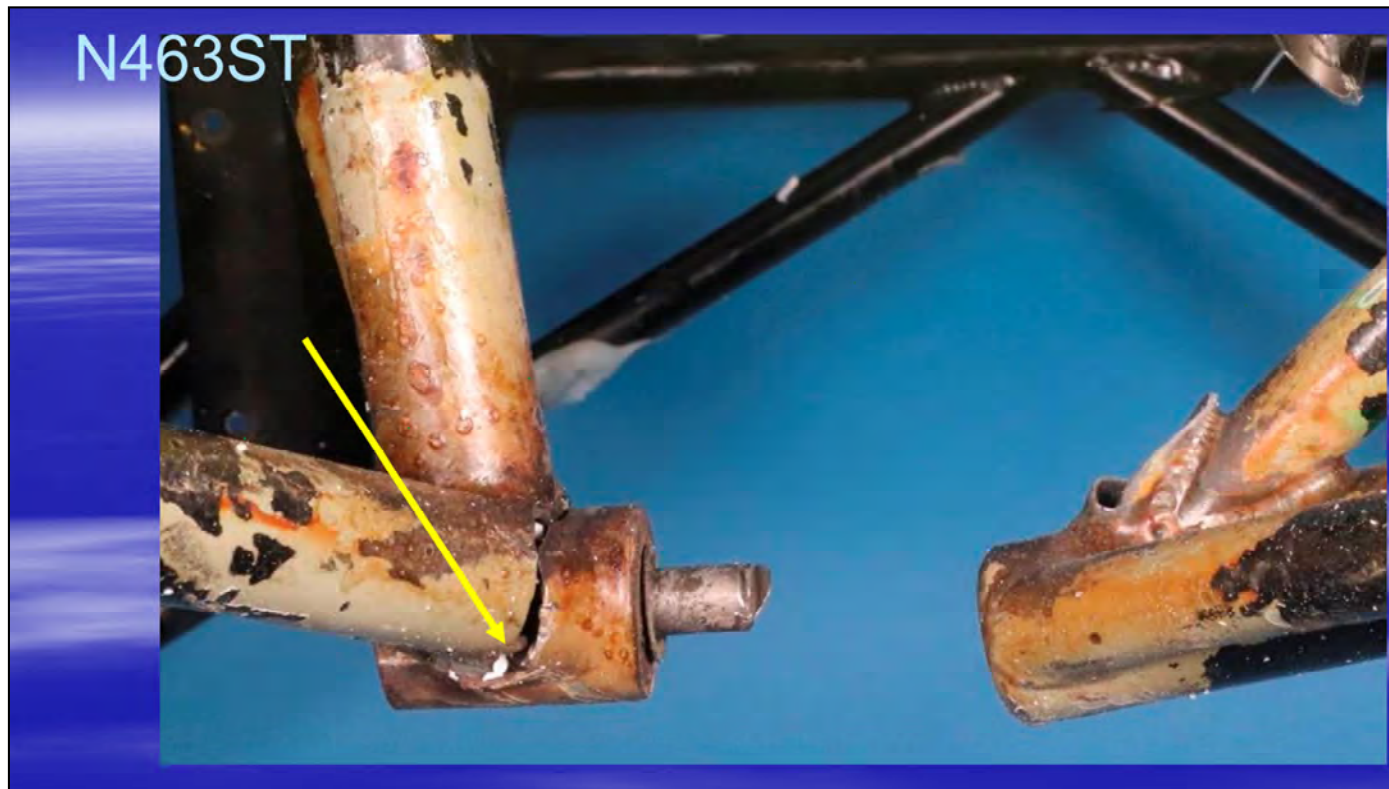
Here's a close-up of the actuator attach feet.

It's easy to see where the right foot failed (pointed at by the yellow arrow), with that large crack.

You'll recall this is the SB that requires annual or 100-hr inspections of the engine mount nose gear actuator attach feet, looking for cracks.

If a crack is found, it mandates replacing with the new stronger mount.

Repair of cracks is not mentioned, so by implication, no mount repairs are allowed.

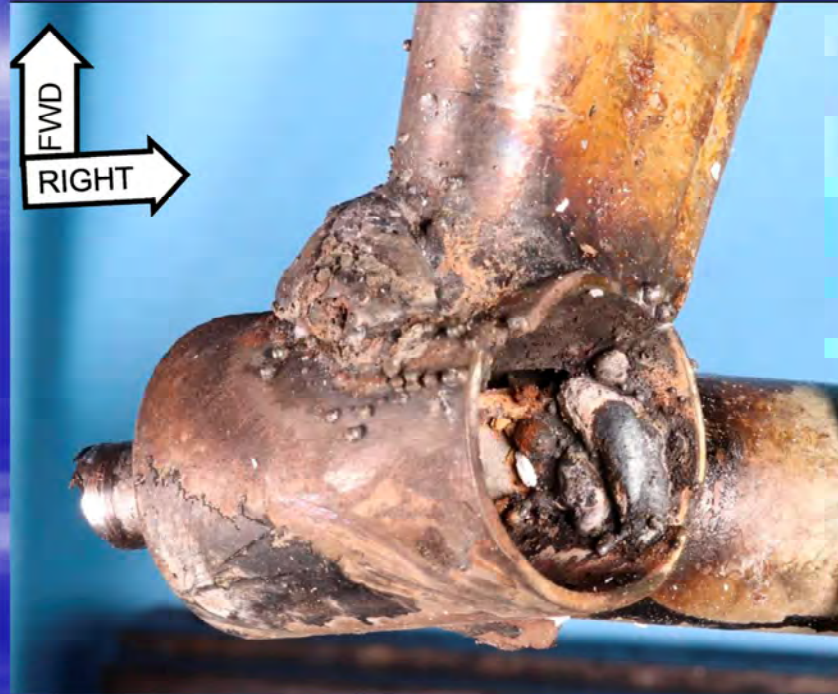
N463ST

Here's a close-up that attach foot showing both inside and outside of the tubing.

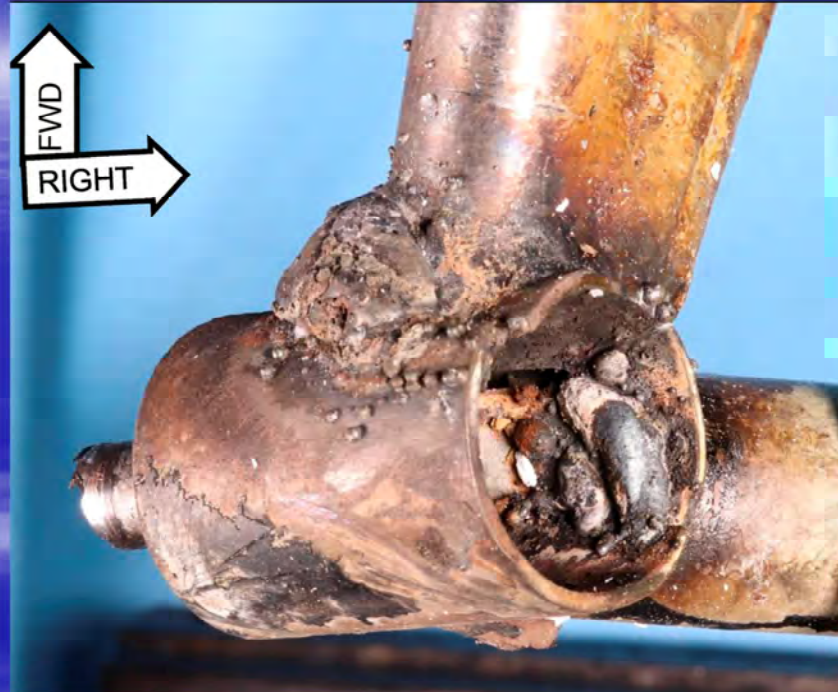
N463ST

The pilot owner had purchased this plane in early 2019, almost 2 years prior to the accident. The mount repair wasn't done during his ownership.

And in fact, there was no mention anywhere in the logbooks of this repair; so we don't know when it was done. But this repair was certainly contrary to Piper's SB.

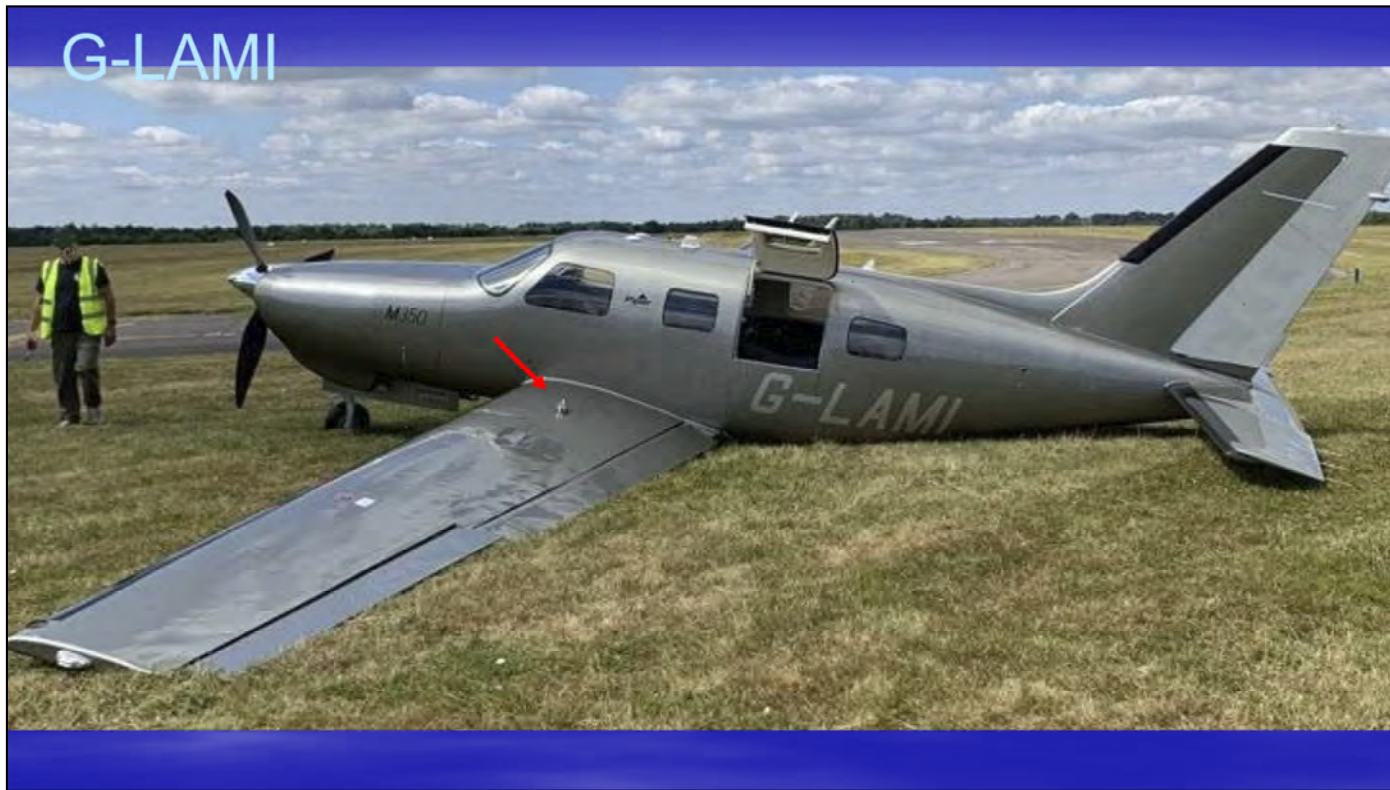
The plane ran off the asphalt, the left main gear collapsed and punched up thru the wing (which you can see in this picture). The right main gear also collapsed, and the plane came to a stop.

So the result was major plane damage, but no occupant injuries.

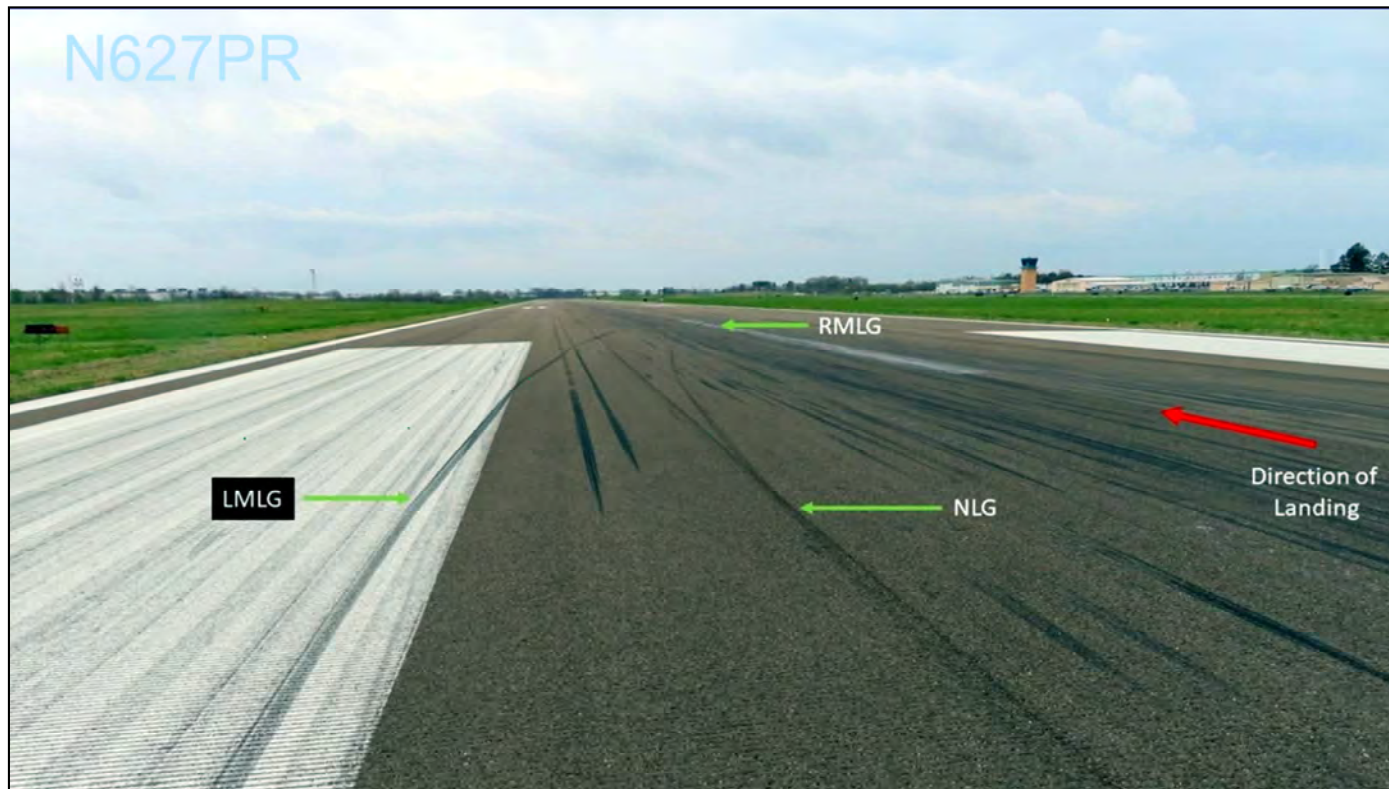
Then, about 2 seconds after the nose gear touched down, the tire marks start a turn to the right, consistent with the pilot's statement that he steered back towards centerline.

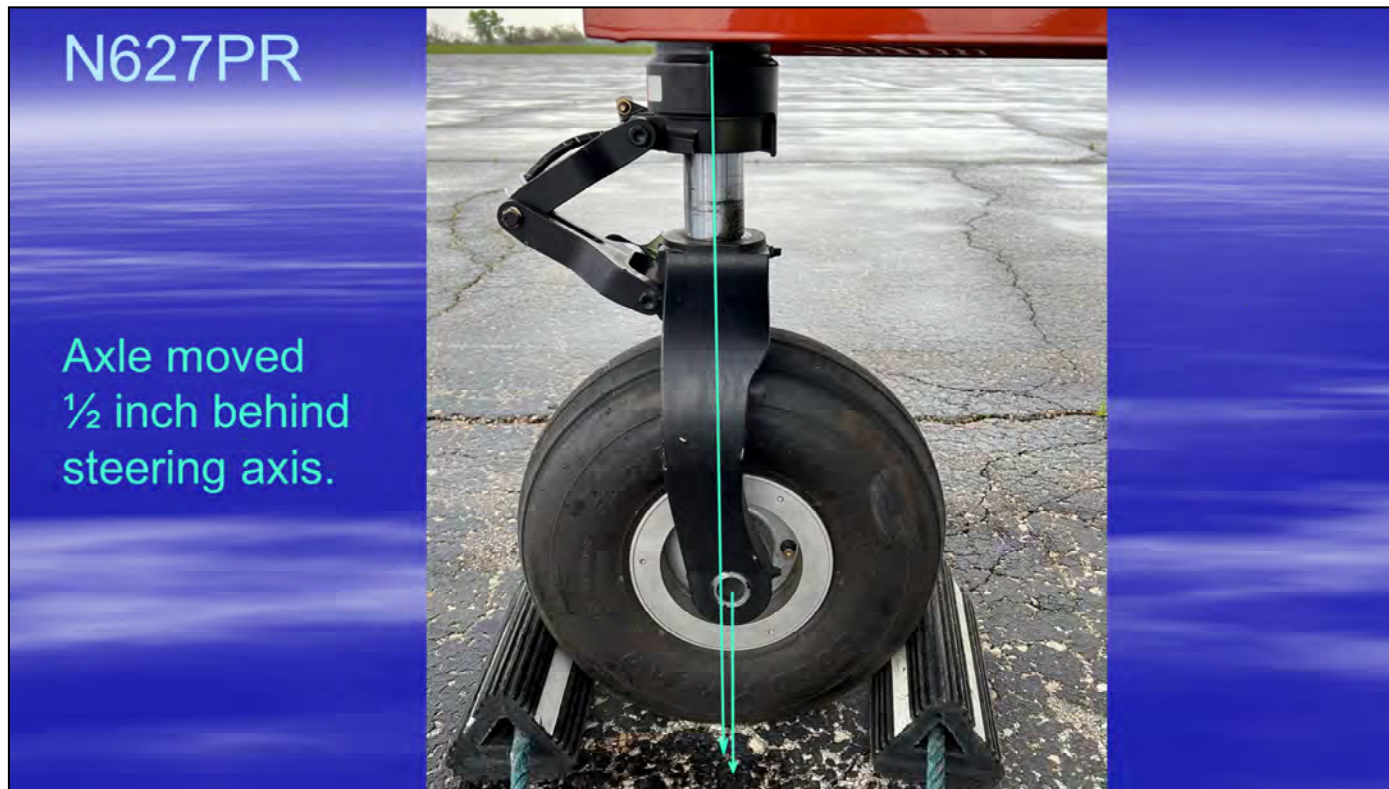
This is a small rear offset (like those supermarket wheels). Seems like a tiny difference, but the NTSB says it's the equivalent of raking the nose wheel 5 degrees forward, which we saw results in positive dynamic stability.

The NTSB also talked about Piper's redesign of the M600 nose gear fork, which moves the axle ½ inch behind the steering axis.

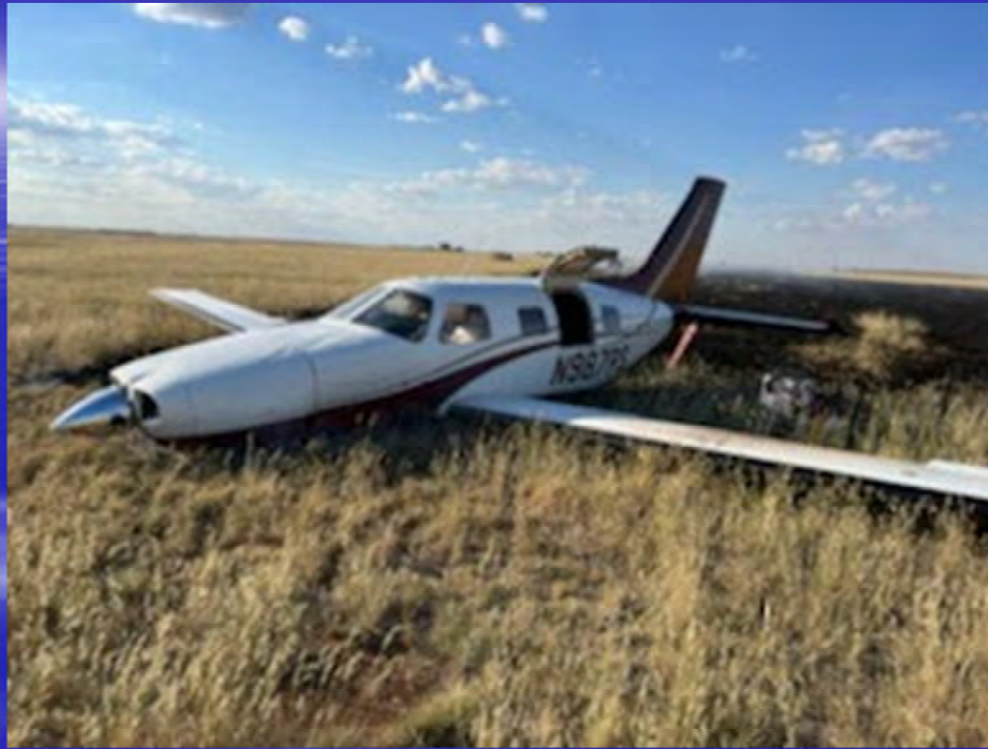
N987PS

There were no injuries, but substantial plane damage.

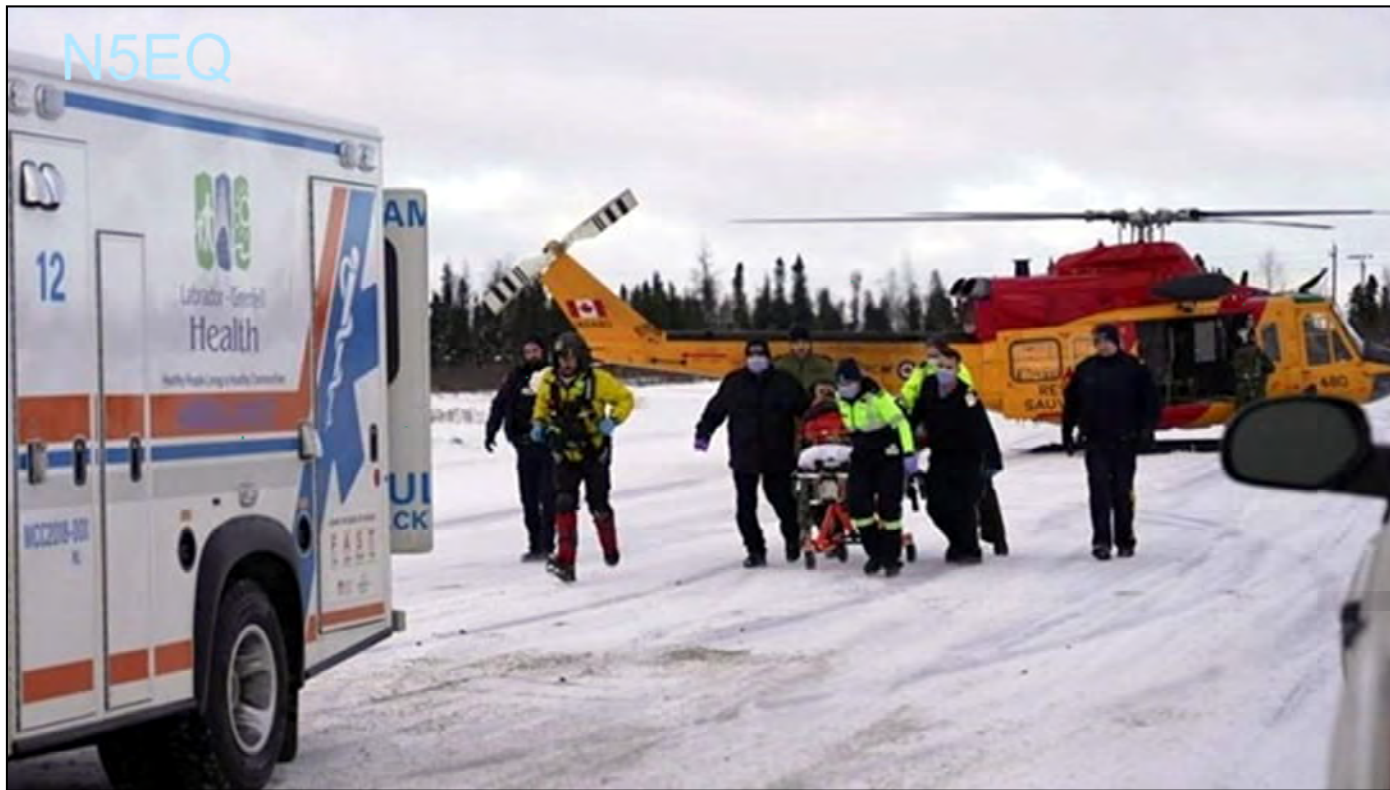
The pilot and his wife were taken to the local hospital, where the pilot died that afternoon. The wife was in serious condition, but I believe she ultimately survived.

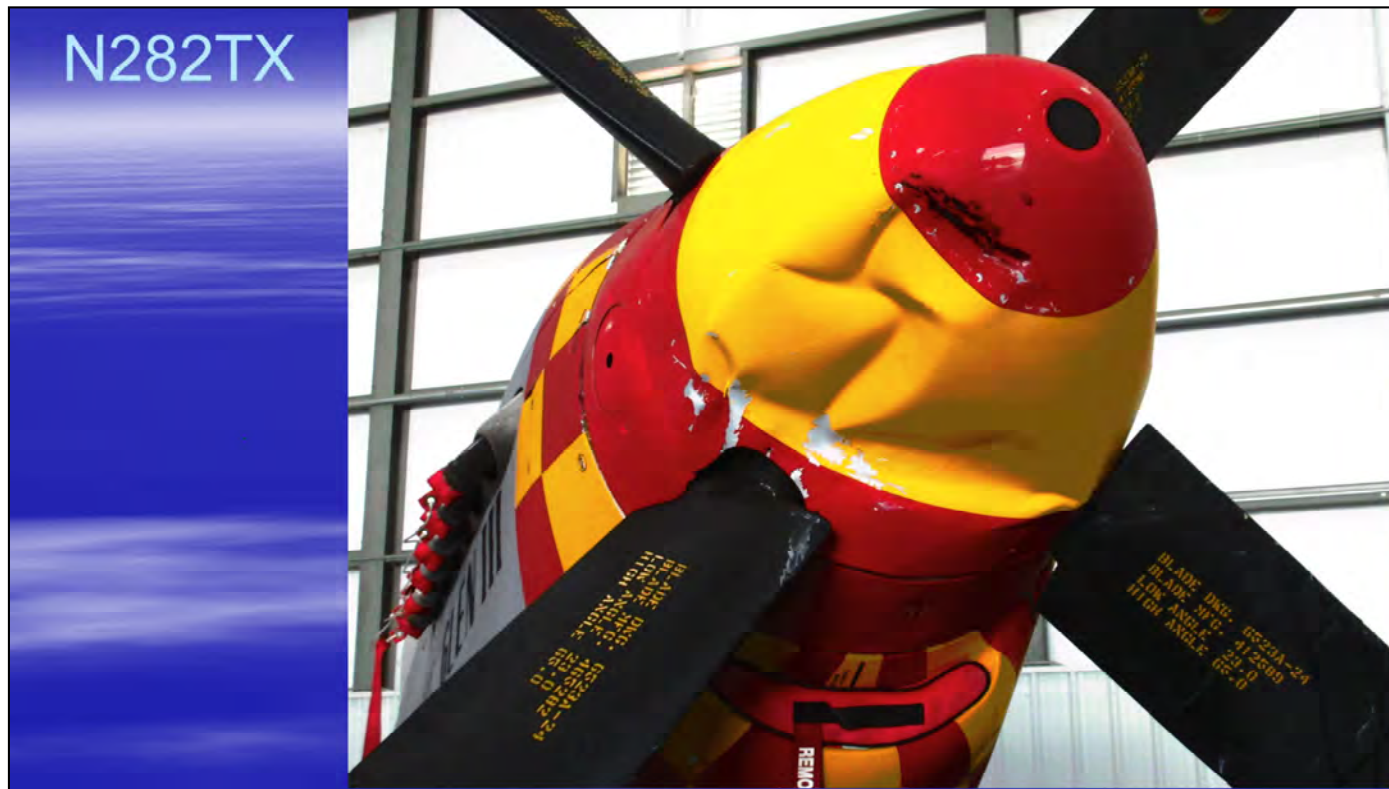
In case you're wondering, the damage to the P-51 was much less severe...

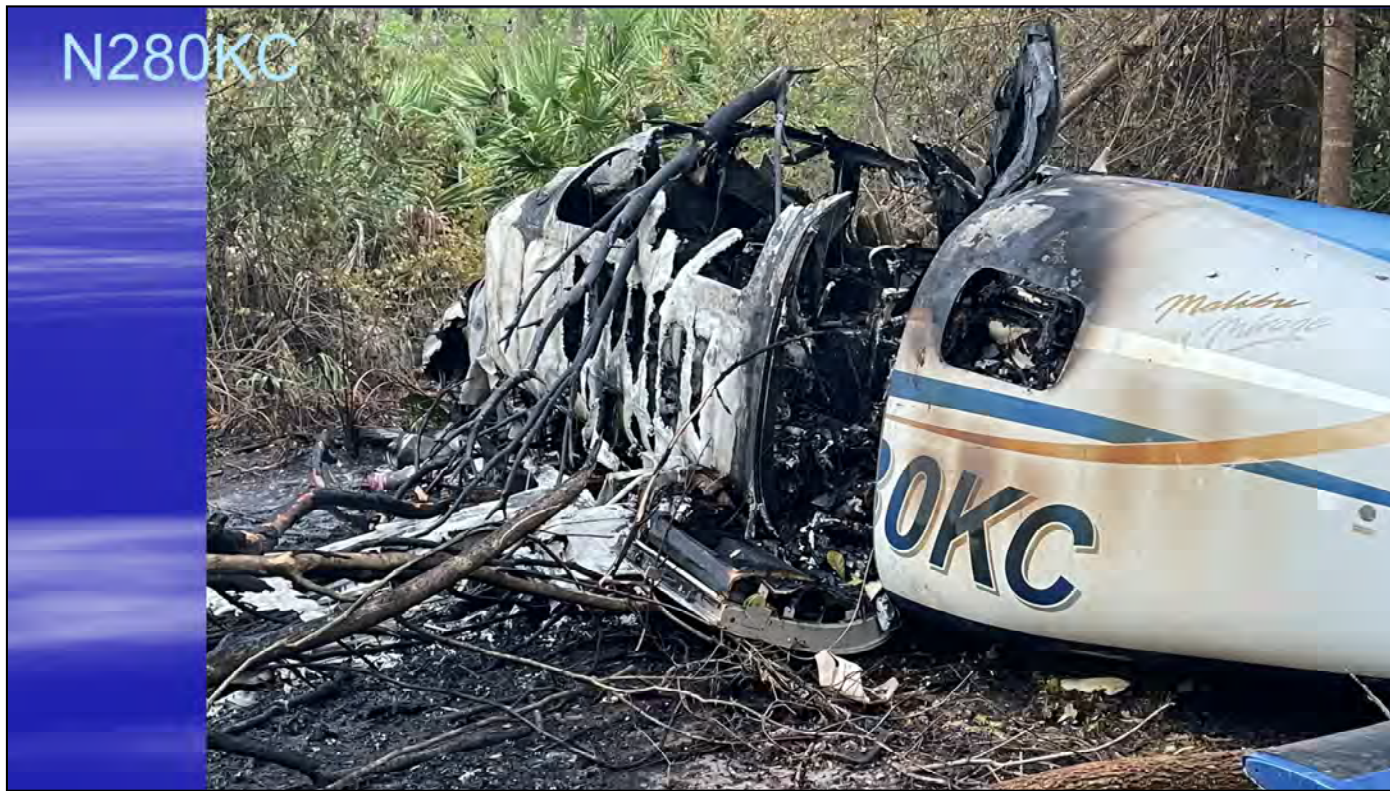
I don't know for sure why this plane settled into the ground.

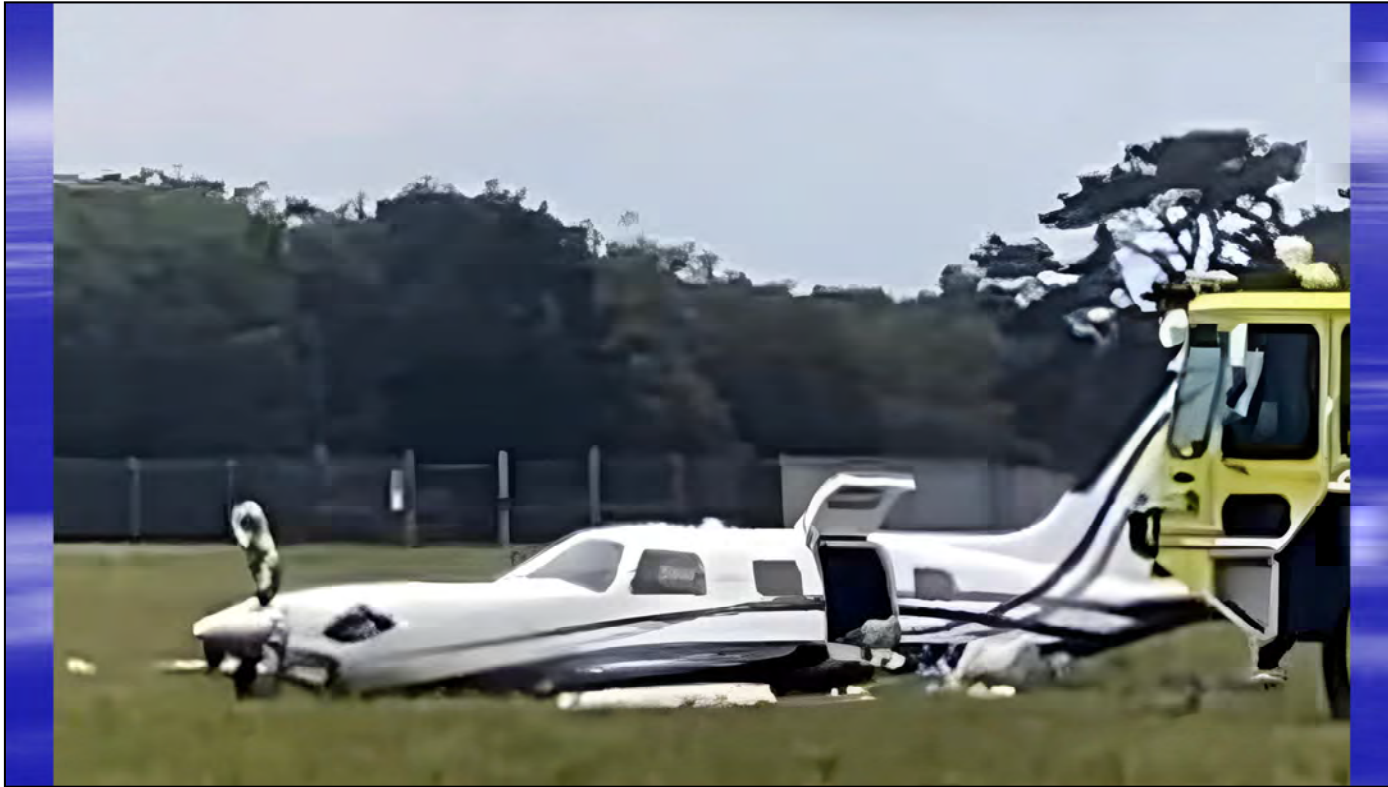
The gear-up landing was off-runway, and the plane sustained significant damage. But the passenger flying was not injured. The pilot died five days later in a Boston hospital.

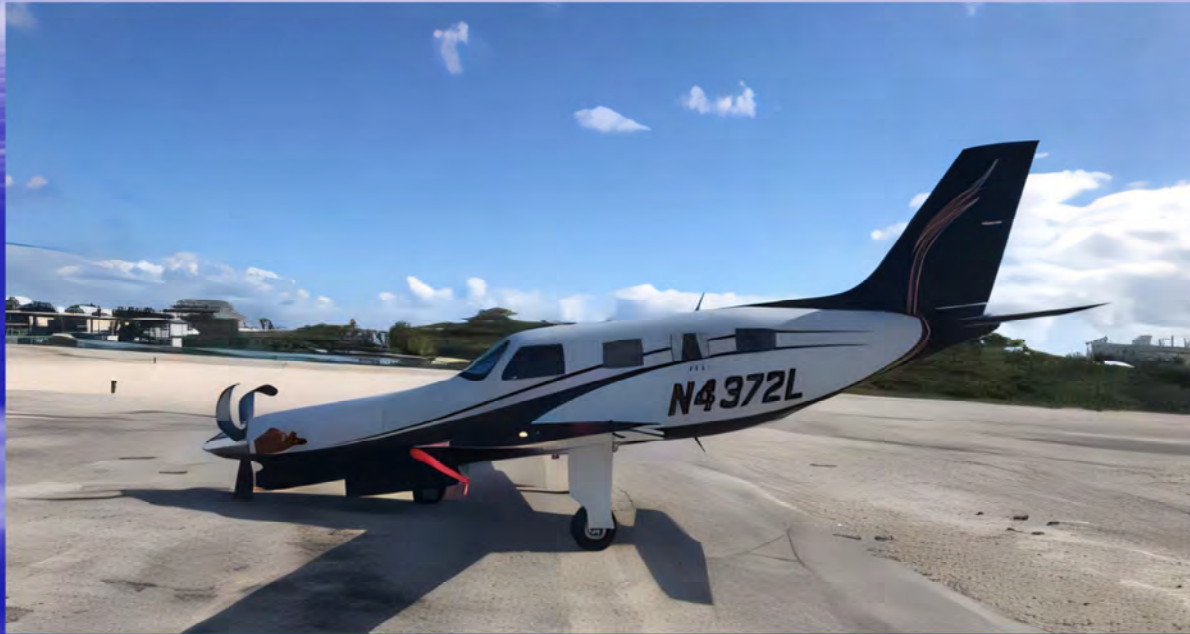
N4372L

The nose gear actuator rod was bent 70 degrees. The Bahamas report implies this was the cause of the gear collapse, but that misses the question of why and how was the rod bent in the first place.
