Hello! Good morning, and Welcome to our 2023 convention!

My goal today is to discuss the accidents that have occurred since our Tucson Convention last year, and then try to put them into the larger context of MMOPA's mission of improving safety.

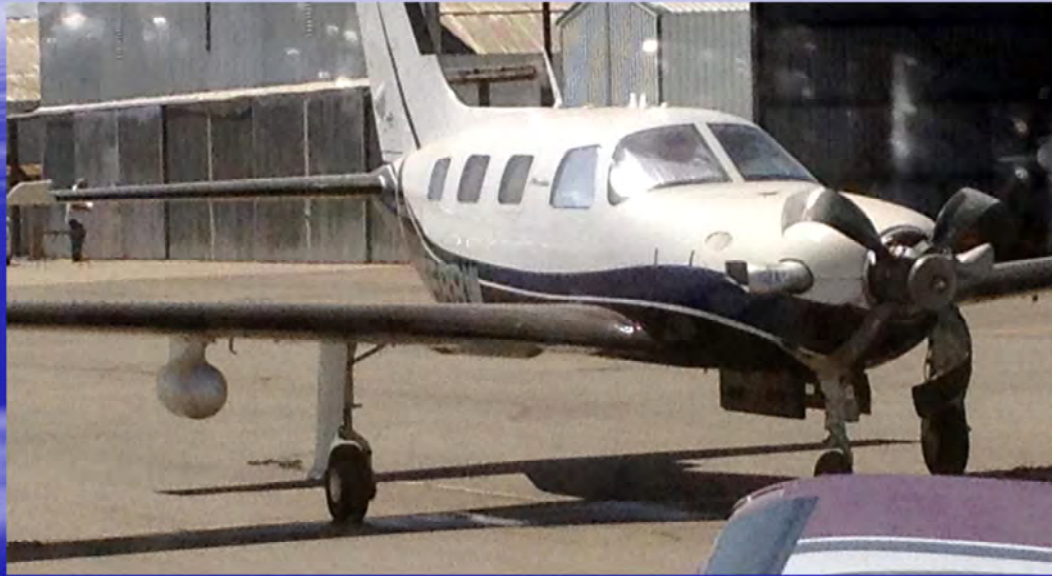
So under that definition, this gear up landing never made it into the accident database.

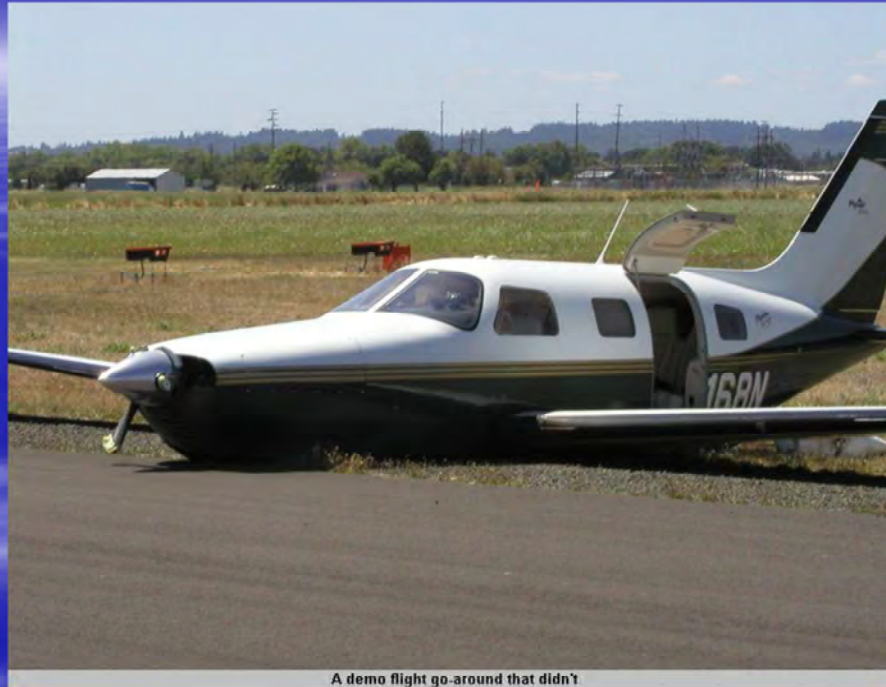
Nor did this botched go-around.

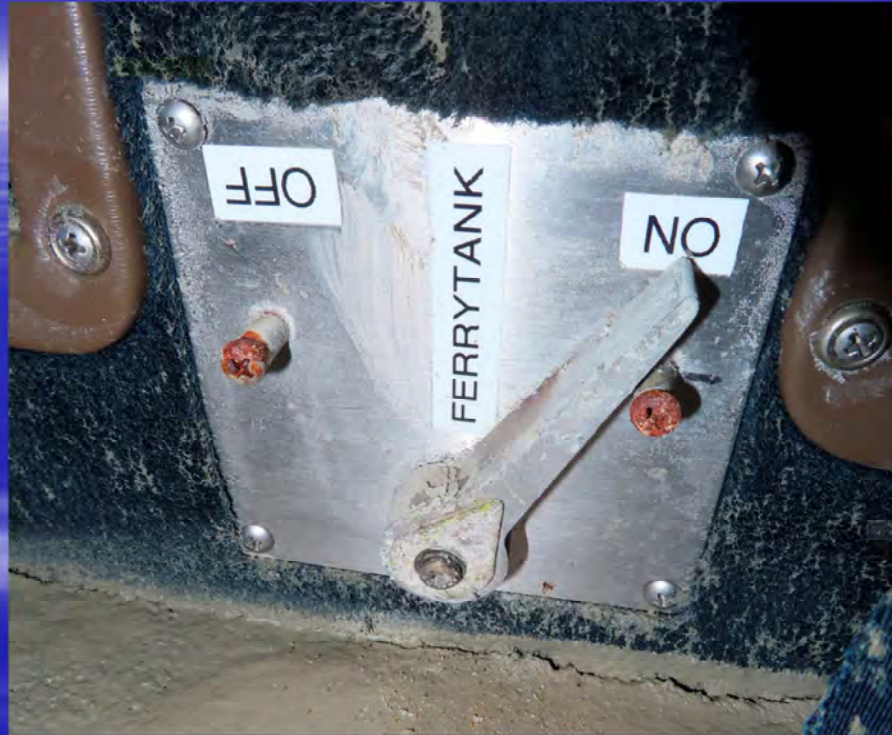
N662TC

This is the valve that was installed with the ferry tank. It's on the forward side of the wing spar between the front seats.

With the valve in the "off" position, fuel flows from the left wing tank.

With the valve in the "on" position, as it was found in the recovered plane and shown here, fuel flows from the ferry tank.

This is a good lesson for us to fully document airframe changes, as well as updating our checklists (in this case – the pre-start checklist and the engine failure checklist) to account for such modifications.

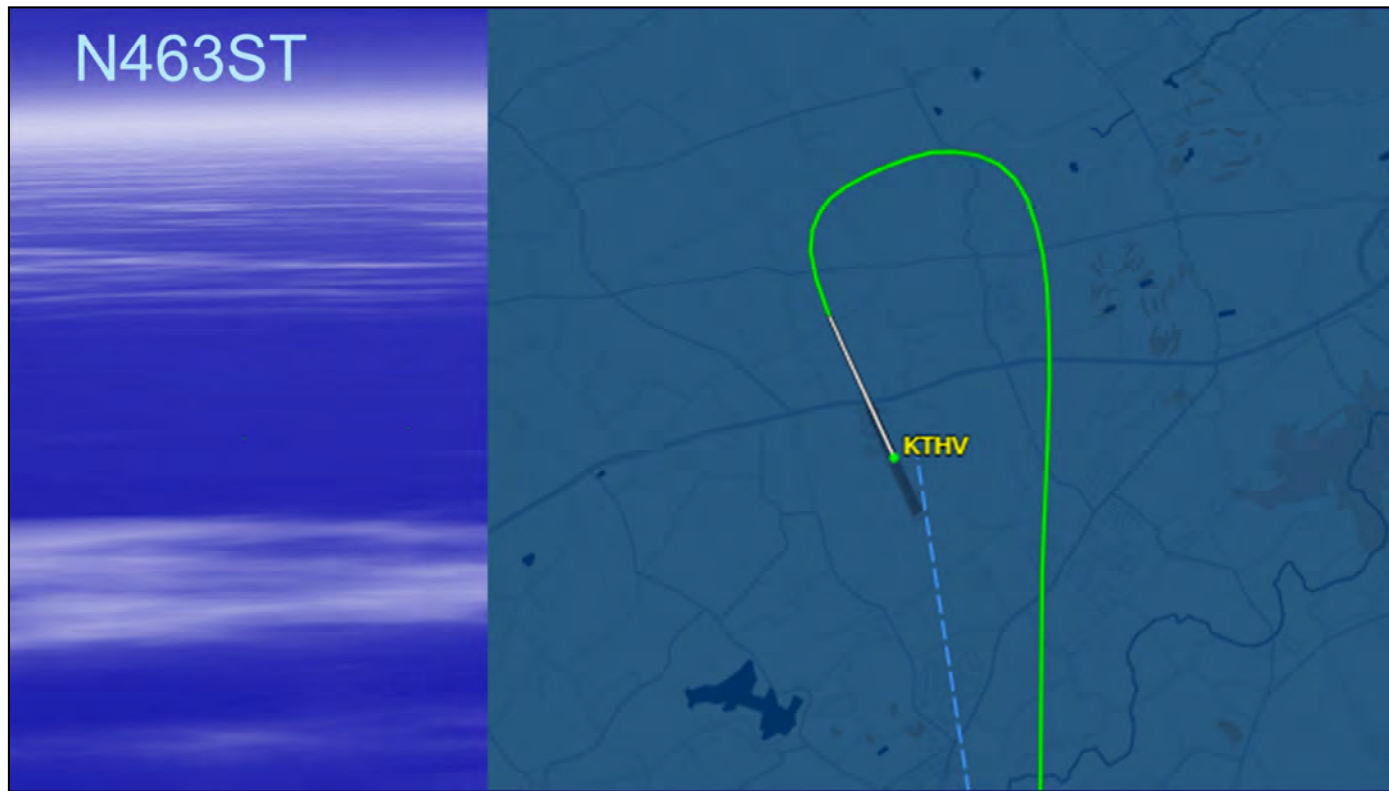
The plane landed on runway 17 at York, and the nose gear collapsed. There were no injuries.

This is another case where the accident chain started years before, as you'll see.

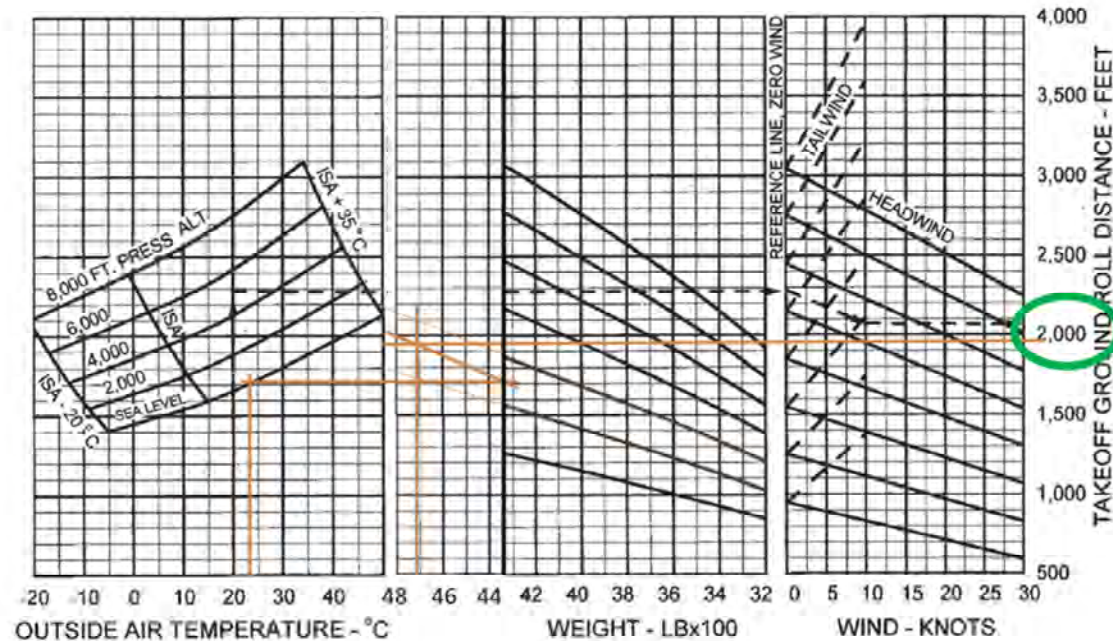
## Appendix 1 - Takeoff ground roll calculation:

Extrapolating from performance tables what the takeoff distance would be for the overweight Mirage yields roughly 2000 feet, if everything was done perfectly. But everything was **not** done perfectly.

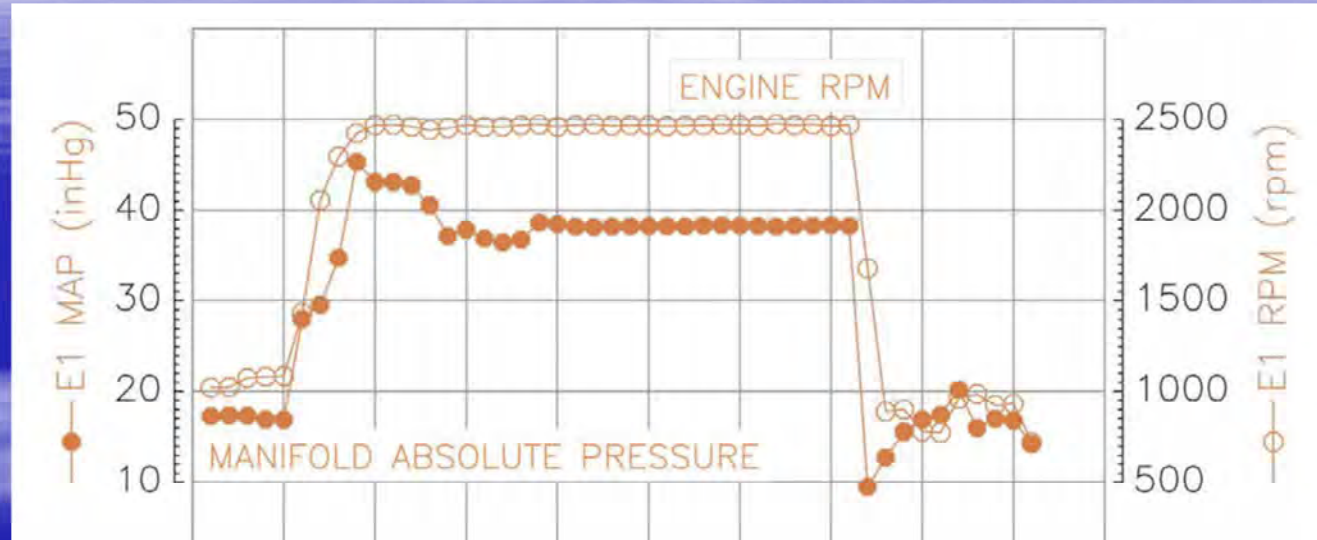
# G-LAMI

The right-seater advanced the throttle. These readings are from the G1000.

Brakes were released at 70% engine power, and the engine didn't reach 42 inches manifold pressure until 3 seconds later, using up still more runway.

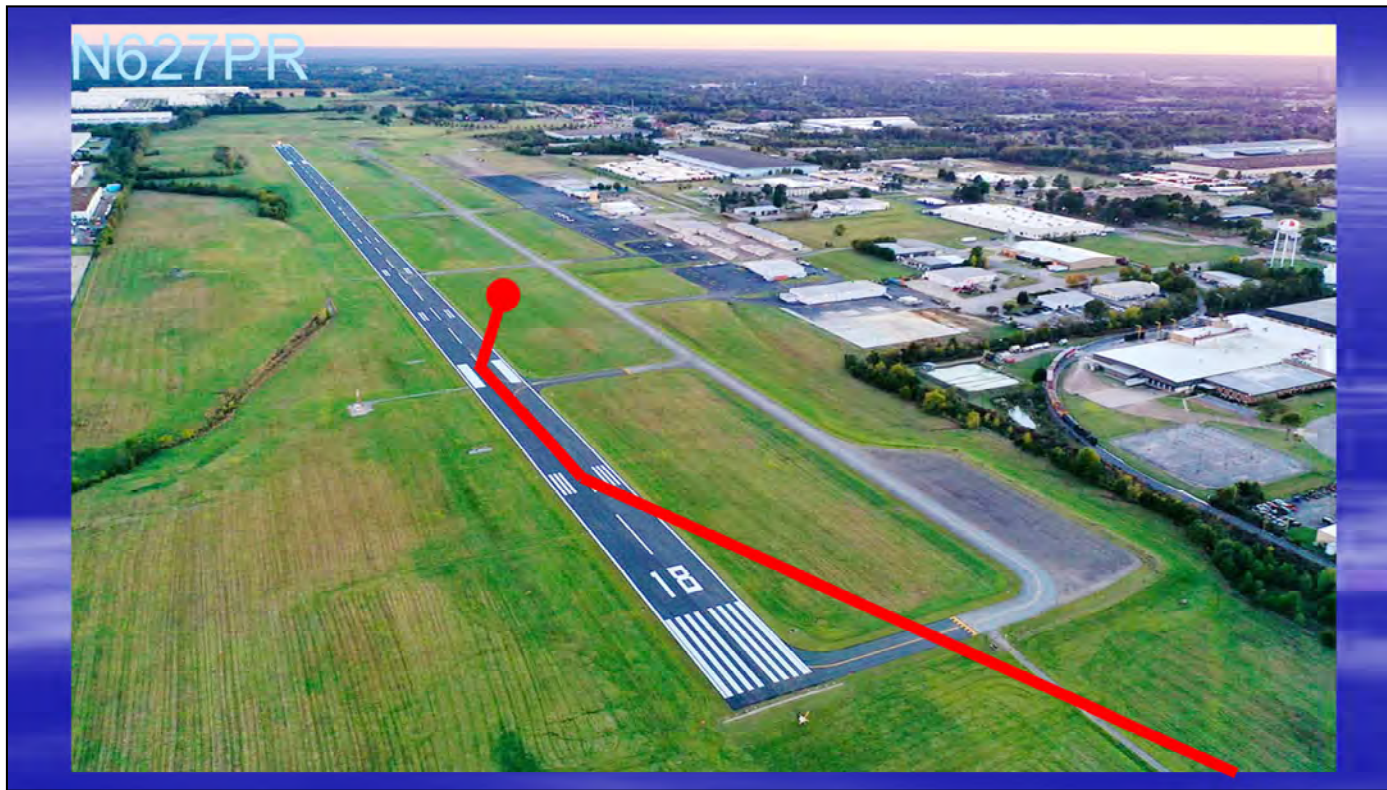
The pilot flew the ILS-18 approach without any problem.

According to the pilot's statement, he touched down at 85 kts left of centerline, and as the plane was slowing, corrected back towards the centerline. The plane skidded, and ran off the right edge of the runway at about 50 knots.

The ground was muddy, and the nosegear collapsed.

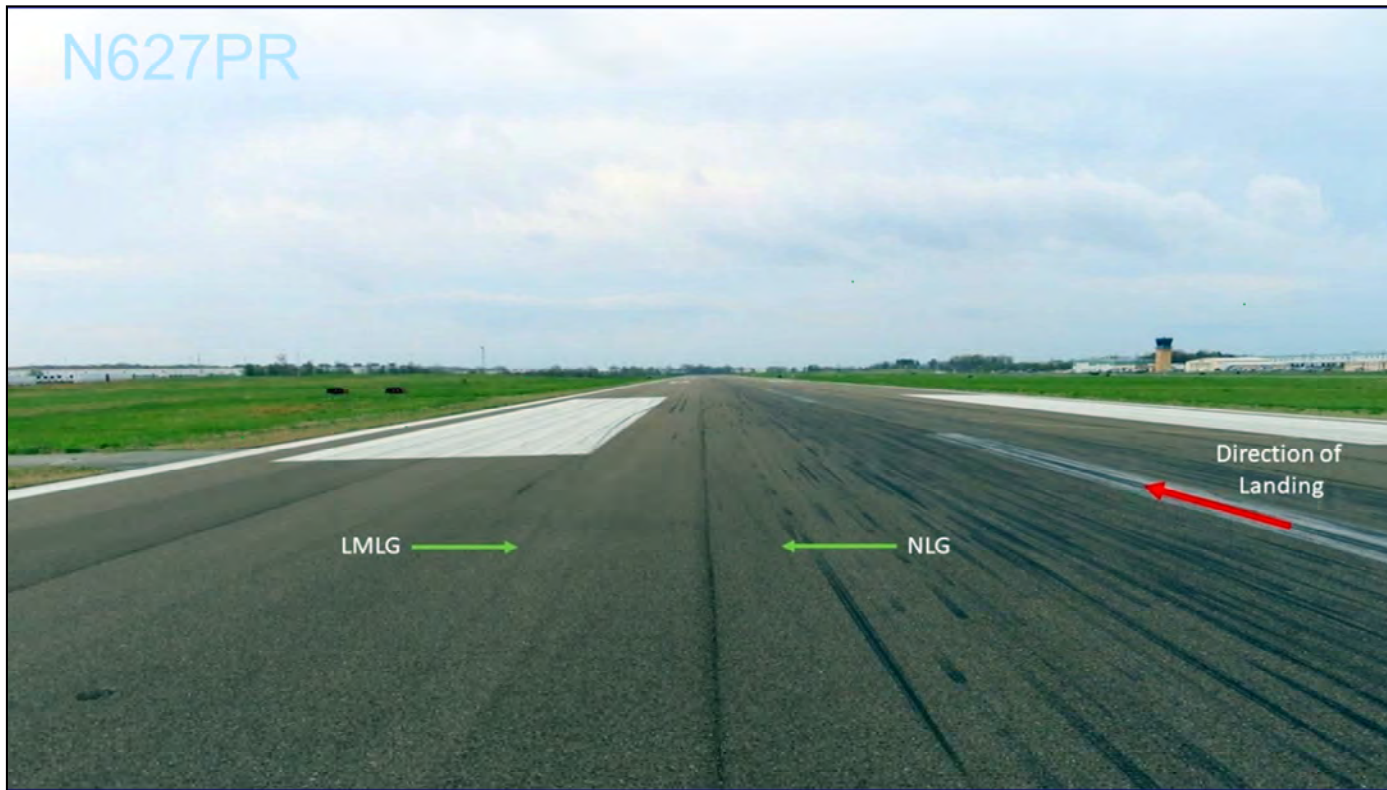
As would be expected with a right crosswind, the right main gear touched down first, about 10 feet left of centerline, followed by the left main gear one second later.

The nose gear touched down last, about 1 more second later.

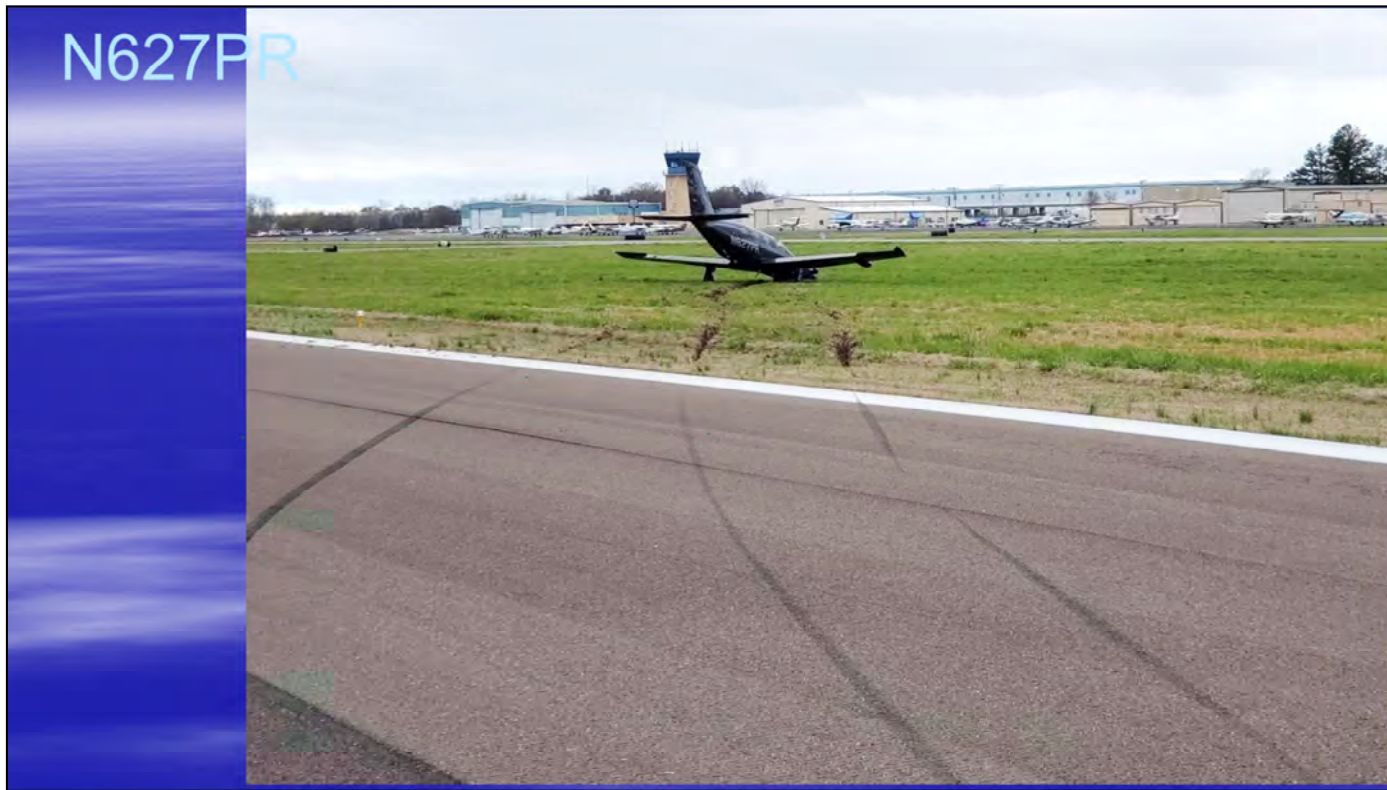
At this point, the NTSB could have just concluded “pilot error” – overcompensating in an attempt to return to centerline, resulting in a skid. Then, as the plane slowed, the tires got a grip, and the angled plane shot off the right side of the runway.

But the final NTSB report is a 16-page discussion of the PA46 nosegear.

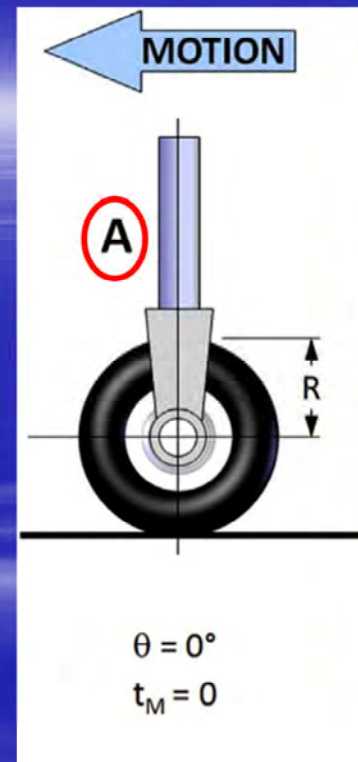
# N627PR

So our nose gear is like A above.

This has the lowest steering effort and is easy to steer at low speed. But it's not self correcting, and if the shaft gets angled back just a little bit, you could have negative stability.

The airplane's uncommanded hard right turn and loss of directional control during landing in crosswind conditions. Contributing to the accident were the dynamic instability of the nose landing gear and the crosswind conditions.

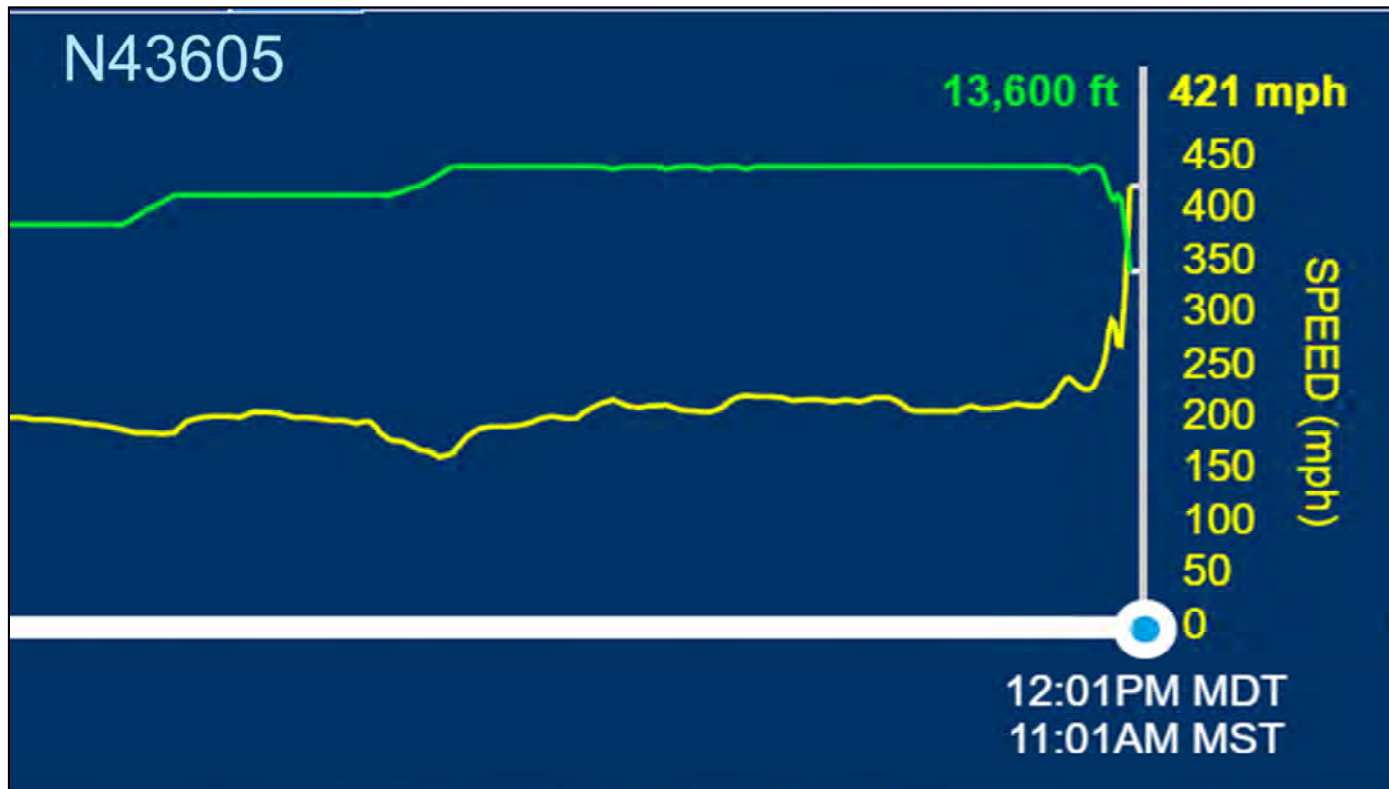
The last FlightAware hit was in a steep descent at 13,600' , going 421 miles per hour over the ground, likely just before an in-flight breakup.

The debris field stretched over two miles, with separated sections of both wings and the tail.

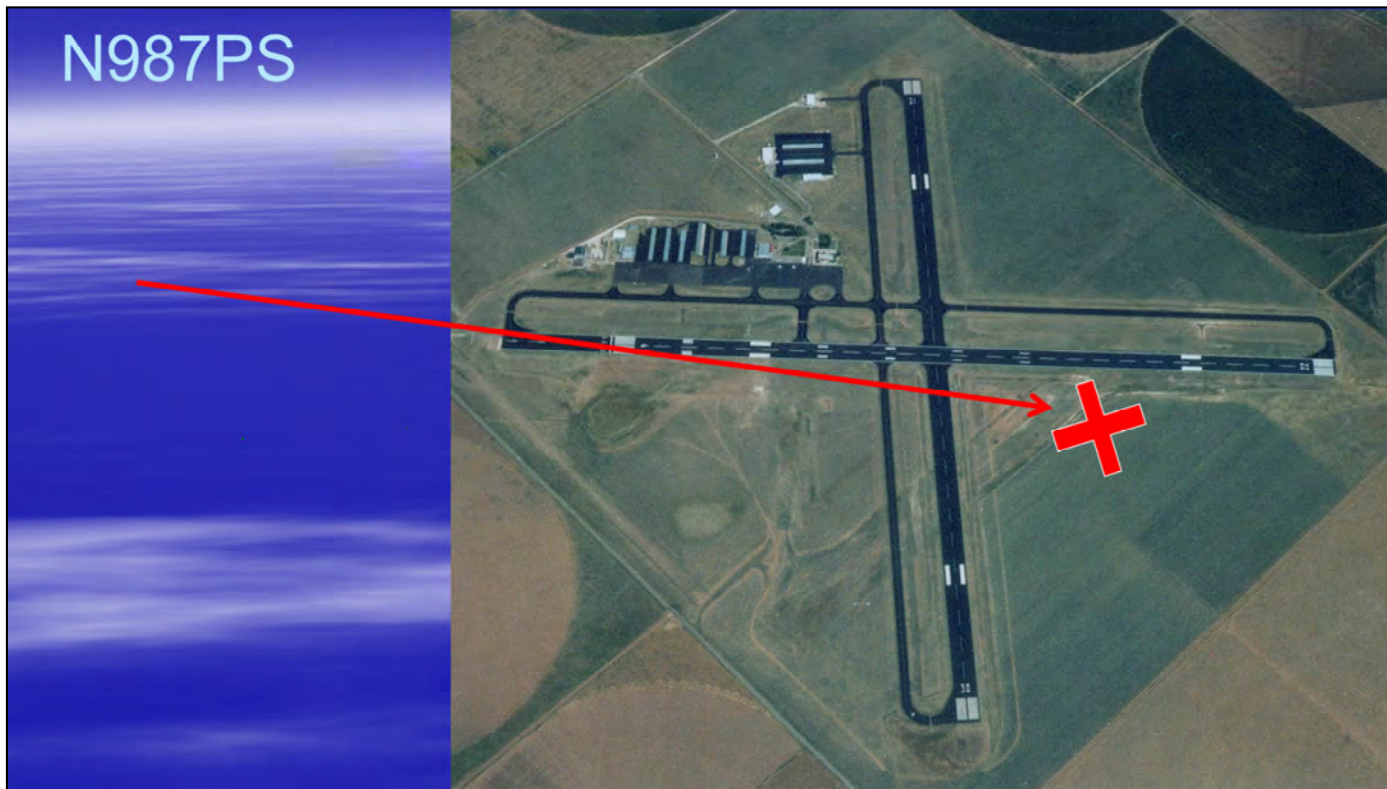
The pilot says a crosswind blew him off course, and he elected to go around.

However, he felt a stall buffet, and then decided to land gear up in a field next to the runway.

They hit a runway sign, and there was a small fire.

There were no injuries, but substantial plane damage.

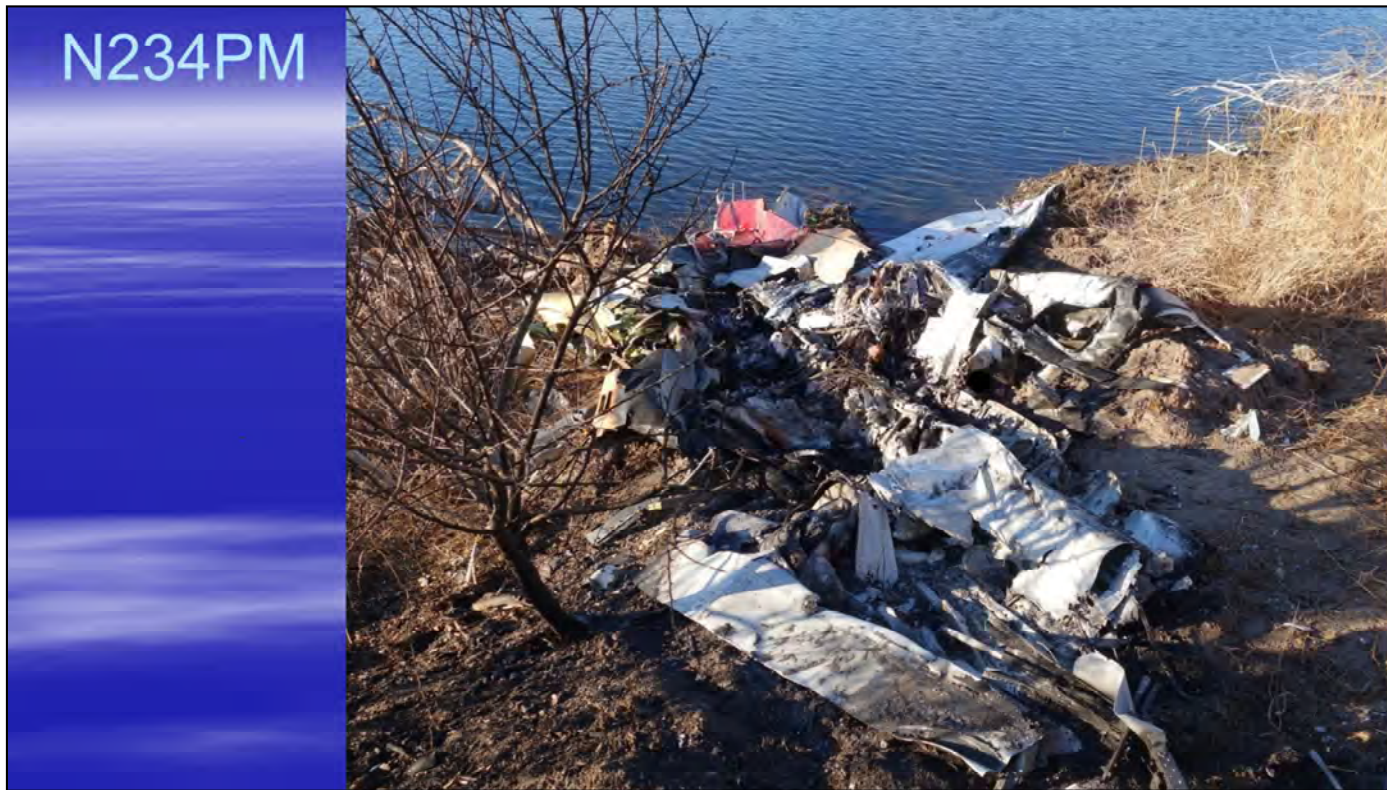
The plane crashed nose down, three miles short of the runway.  
Of course, both the pilot and his passenger died.

Clearly this was an approach loss of control accident. The pilot was very inexperienced with instrument flight, and icing may have played a role, though Scott Denstaedt posted a weather analysis where he suggested the icing was very thin.

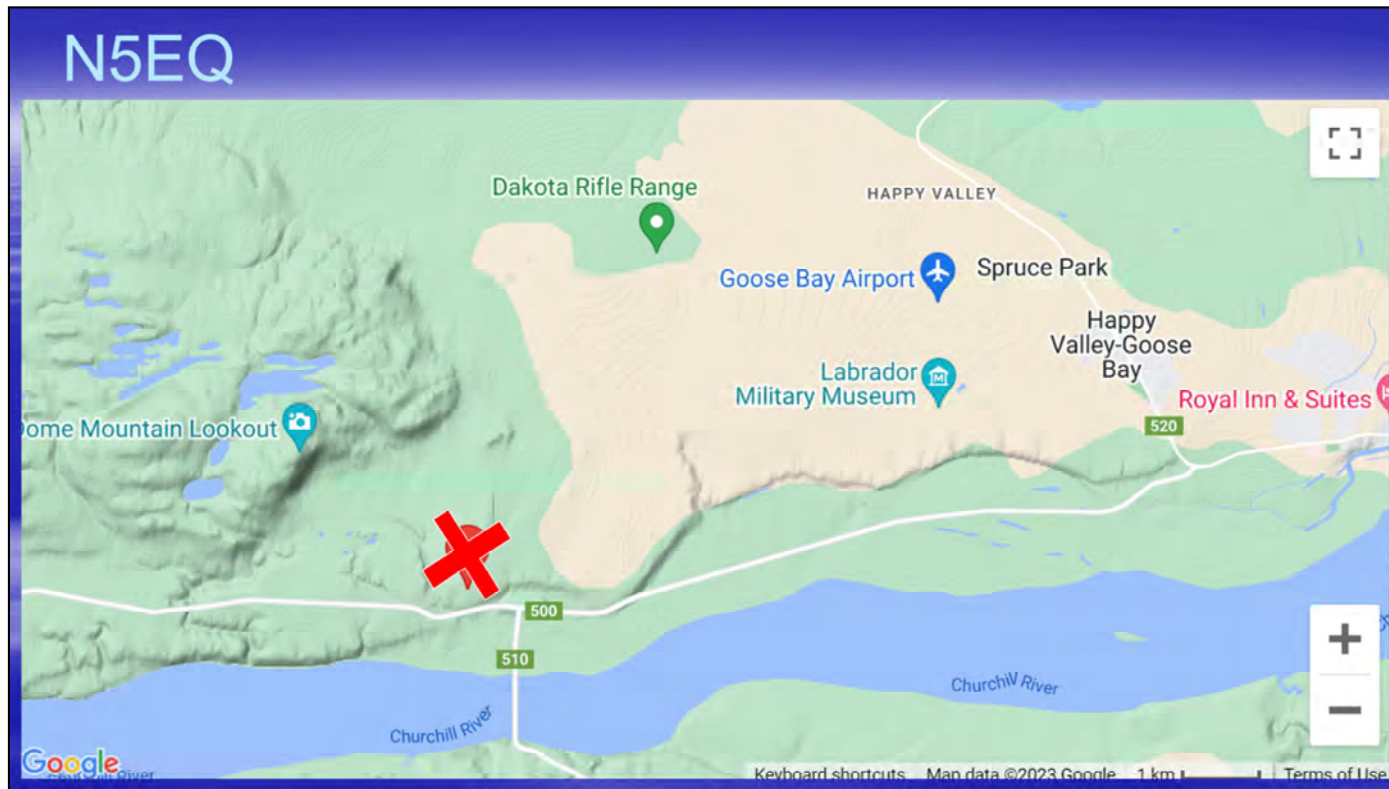
Very shortly after that, tower lost contact with the plane. There was no emergency call from the plane.

The plane crashed 2 ½ miles short of the field, on the extended runway centerline.

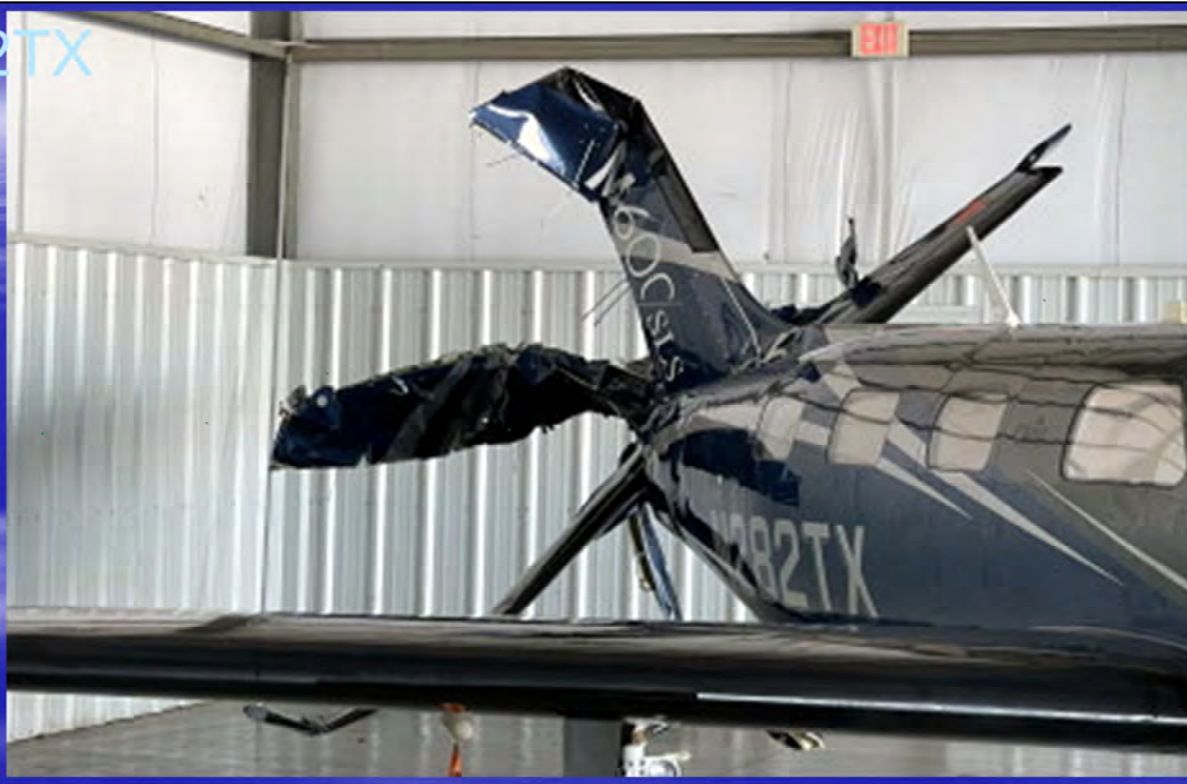
N282TX

That huge P-51 prop chewed up the tail of the M600 badly.

Fortunately, there were no injuries... but I truly feel for this owner...

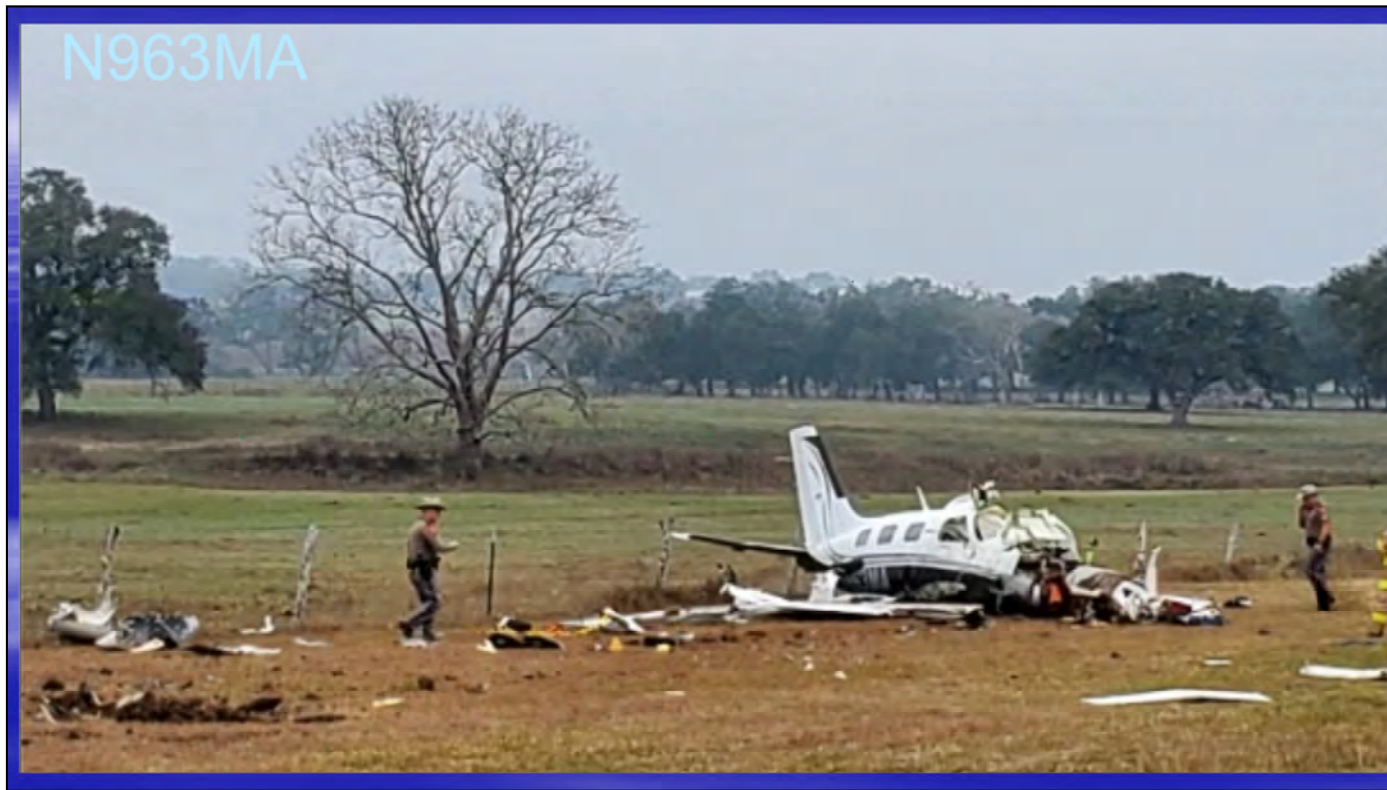
The plane crashed 1.5 miles from the runway, and both wings were torn off.

Amazingly, one of the five occupants survived, and was able to exit the plane and call 911, despite serious injuries.

The other four occupants (including the pilot) died.

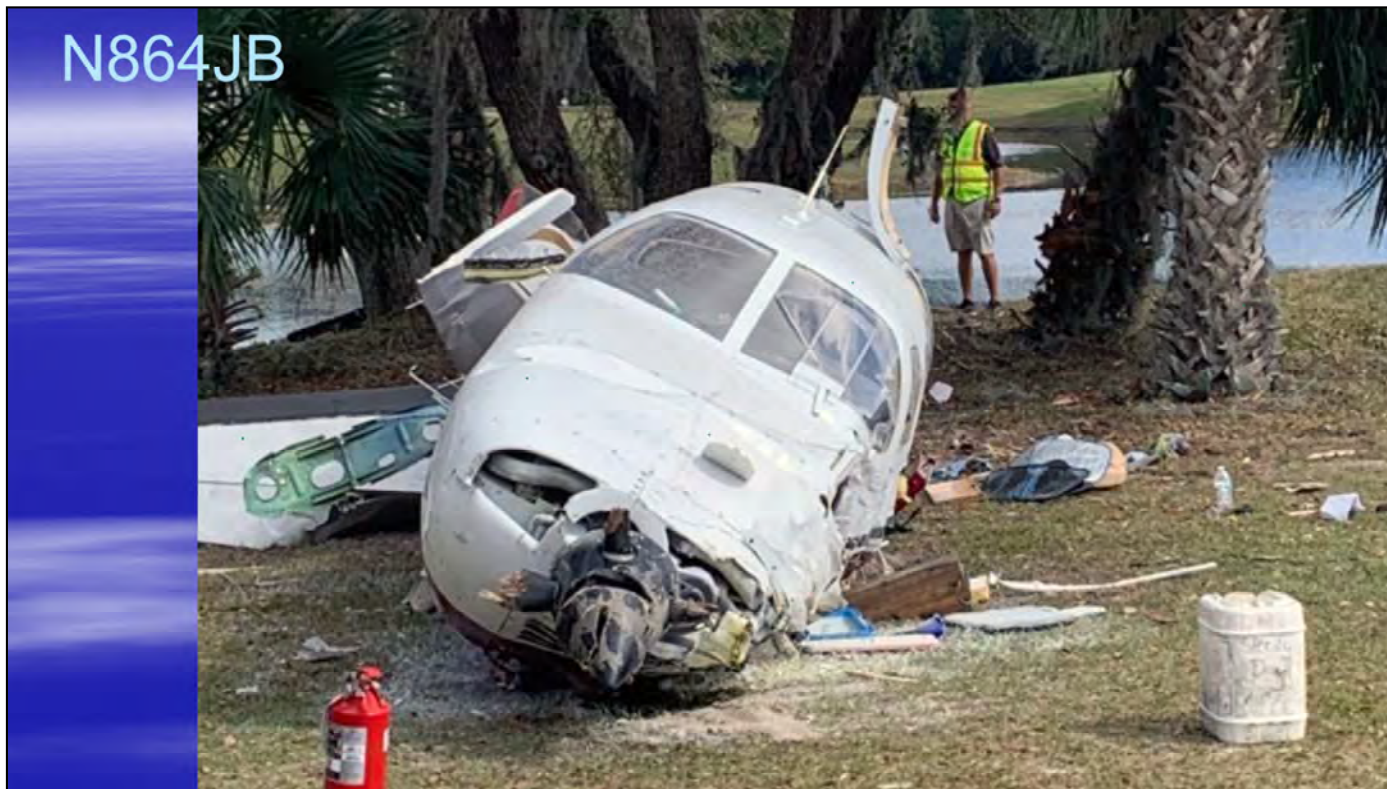
The airplane was destroyed.

The two people on board survived, albeit with significant injuries.

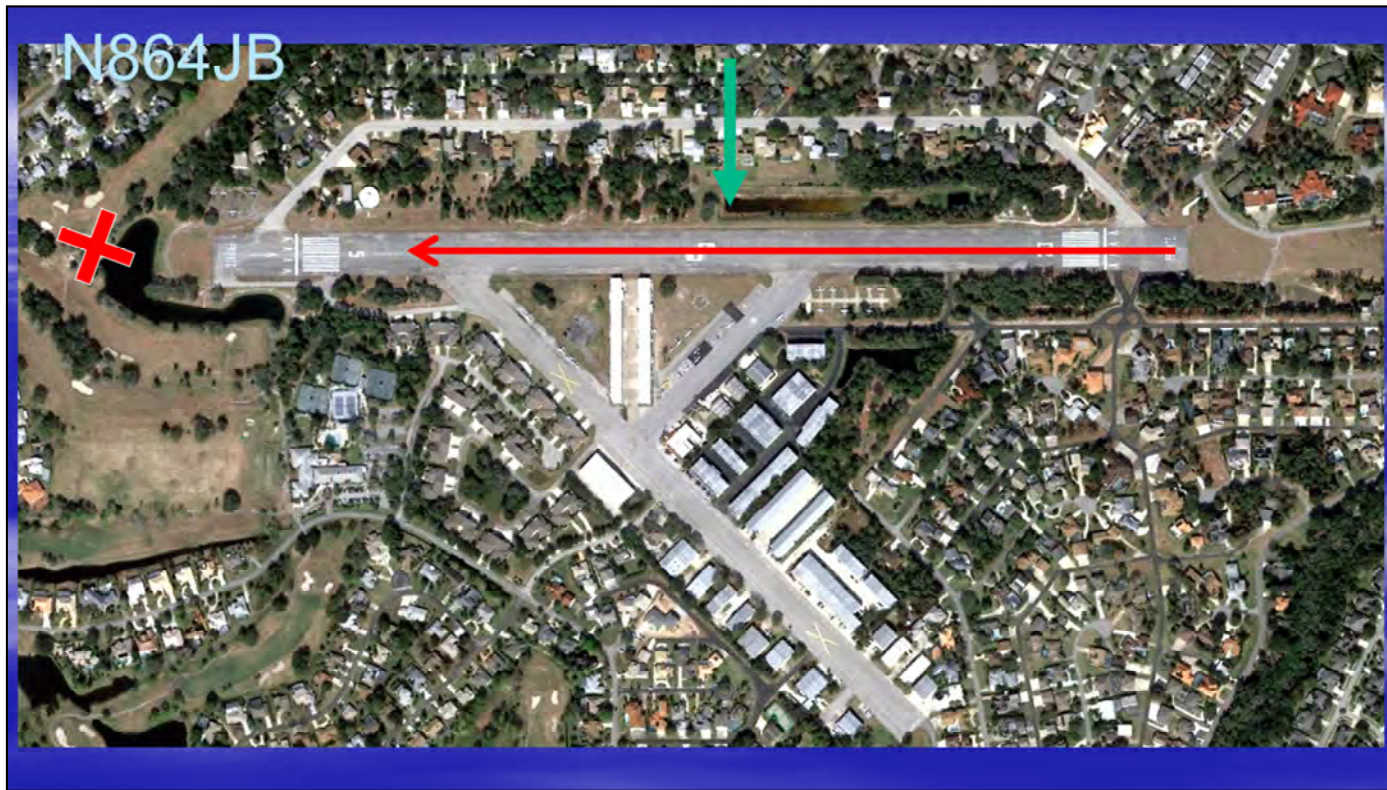
Of course, I wasn't there, but if the pilot had aborted when the right wing initially hit the runway, he would have had enough space to stop on the runway.

Alternatively, if he'd aborted at the stalled hard touchdown, which occurred at the green arrow in this picture, he might not have stopped completely on the runway, but he would have run off the end of the runway at a low speed, rather than hitting trees at just under flying speed.

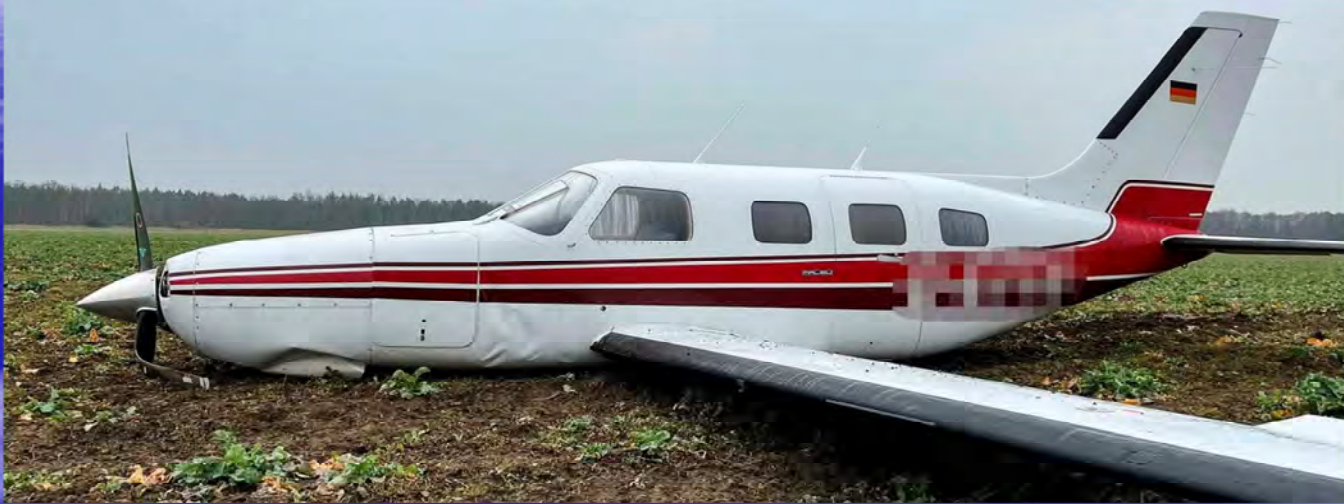
D-ETTG

Fortunately, there were only minimal injuries to the four people on board.

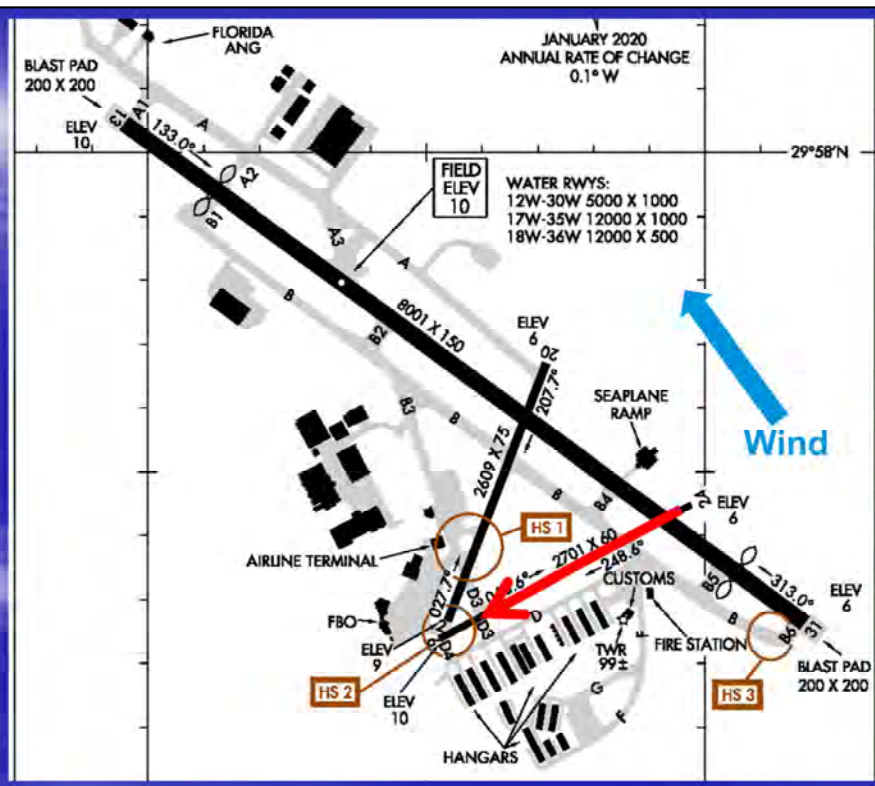
However, the pilot elected to take off from runway 24.

This gave him a tailwind component of 4 kts, and a crosswind component of 11 kts, as well as a slight up-hill gradient of the runway.

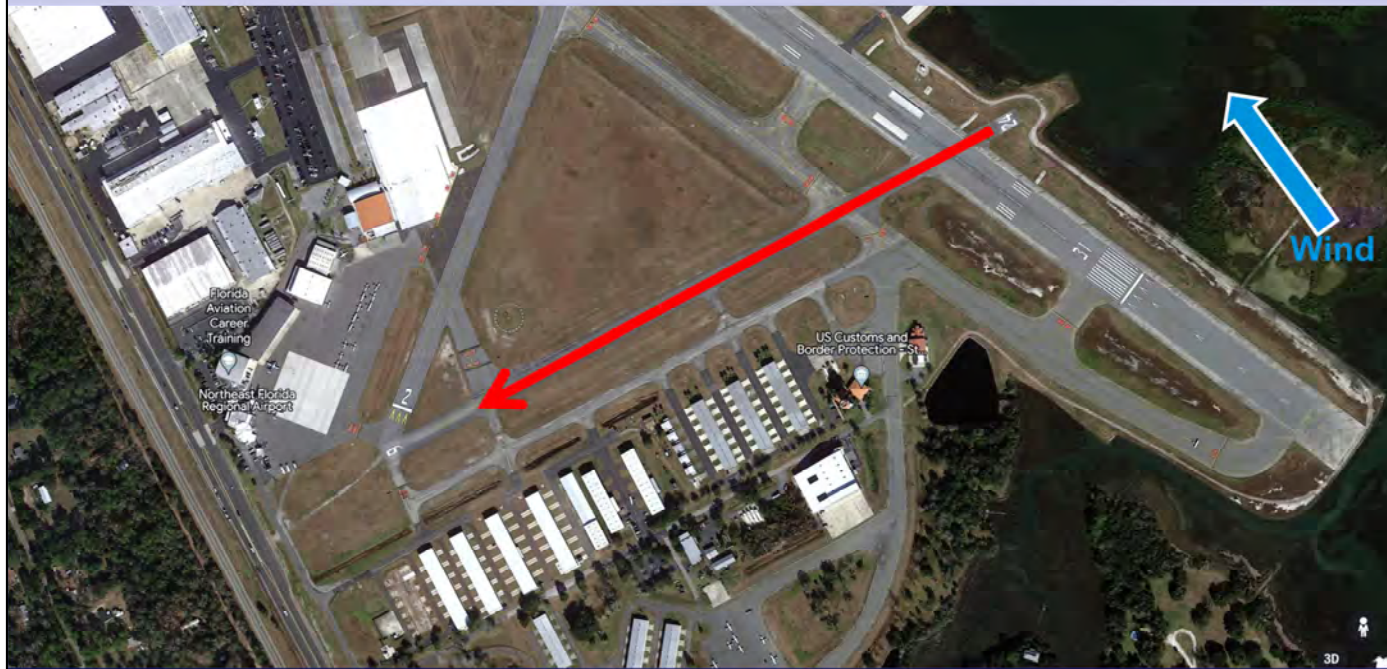
N280KC

You can see that the departure from 24 crosses a highway, and then there are 50 foot trees roughly 1000 feet from the end of the runway. Probably another reason to use the main runway.

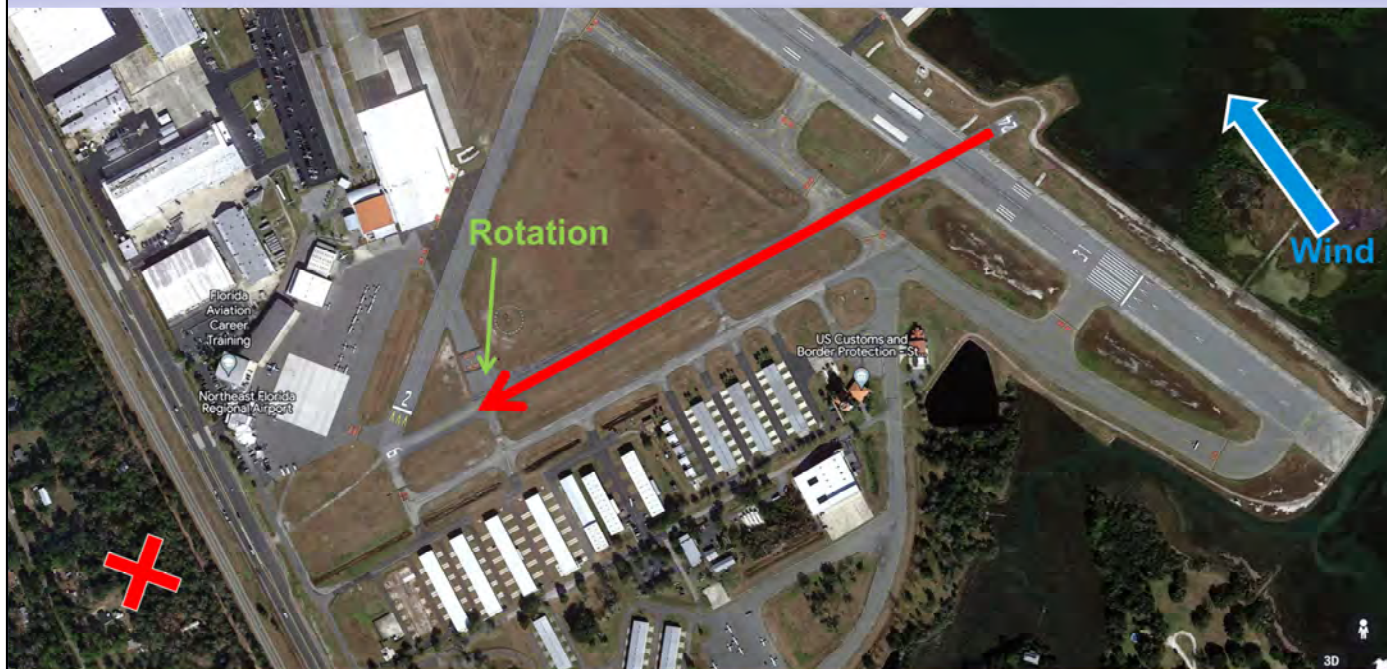
N280KC

A CFI witness says the plane rotated at the intersection of this taxiway.  
The plane cleared the end of the runway, and then pitched up sharply.

The CFI estimated it climbed to about 100 feet, and then began settling and barely cleared the streetlights as it crossed Rt 1.

The plane then struck the trees just to the left of the extended runway centerline.

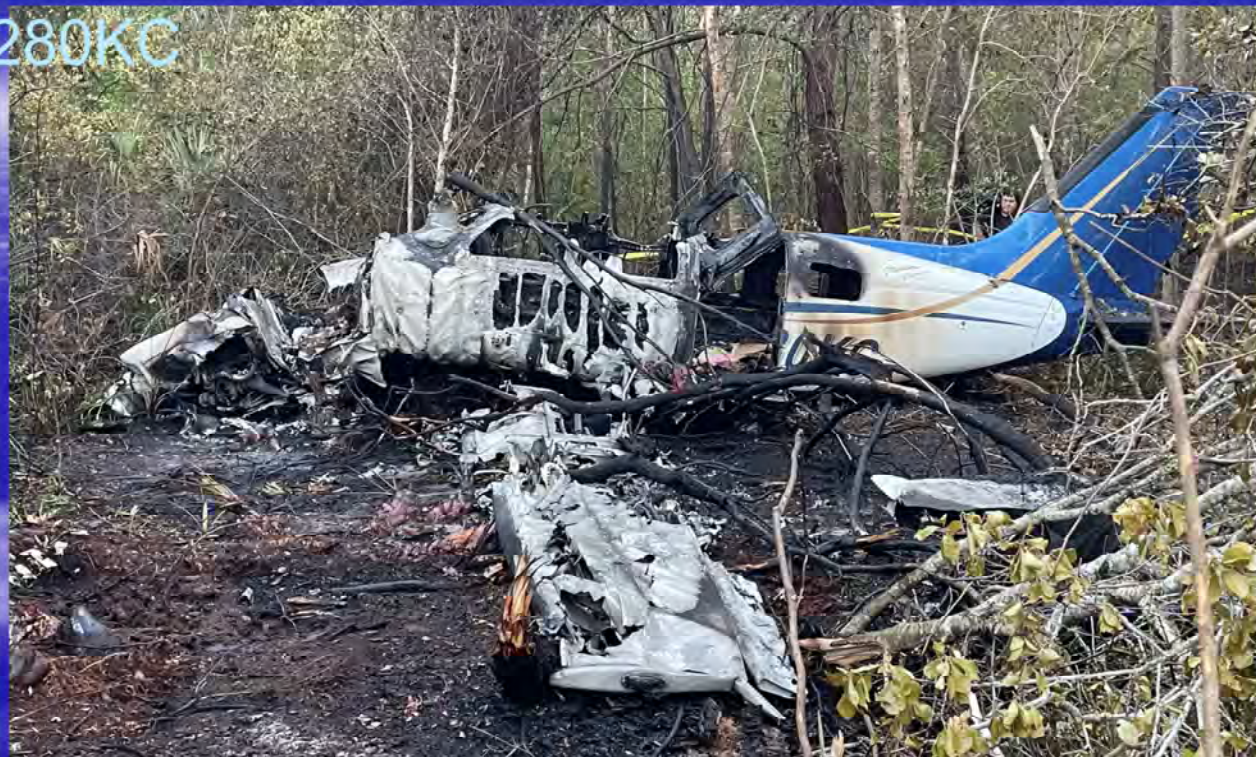
N280KC

The post-crash fire was quickly extinguished, and both people were seriously injured, as was their dog.

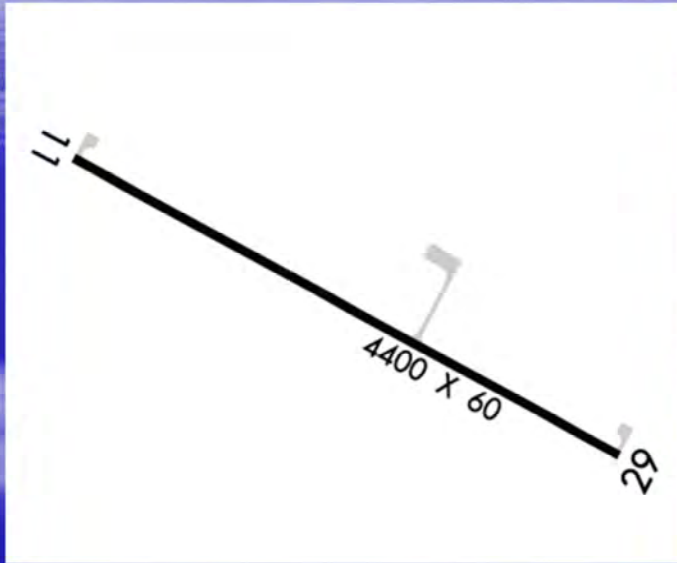
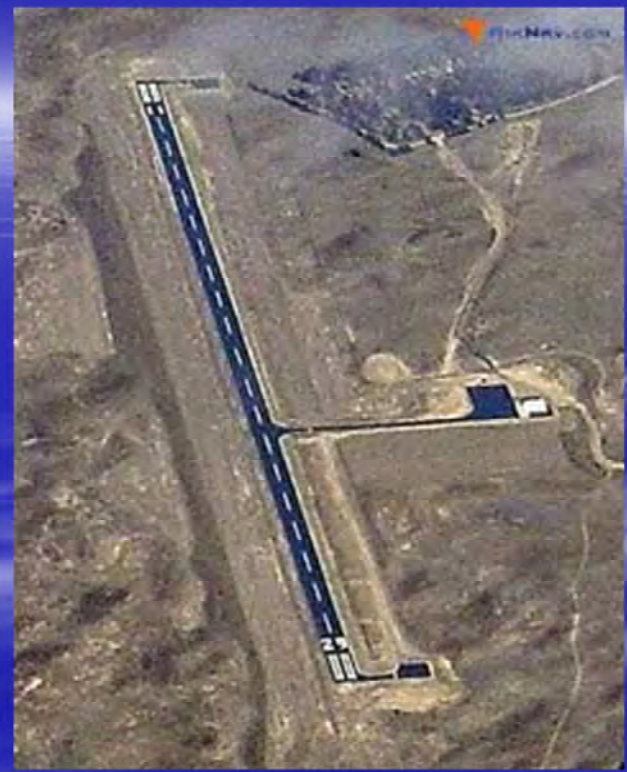
N131HL

They were landing at Thedford in beautiful weather, with clear skies and a 5 knot wind from 140.

Thedford has a 4400 foot runway in good condition.
