Hello! Good morning, and Welcome to our 2023 convention!

My goal today is to discuss the accidents that have occurred since our Tucson Convention last year, and then try to put them into the larger context of MMOPA's mission of improving safety.

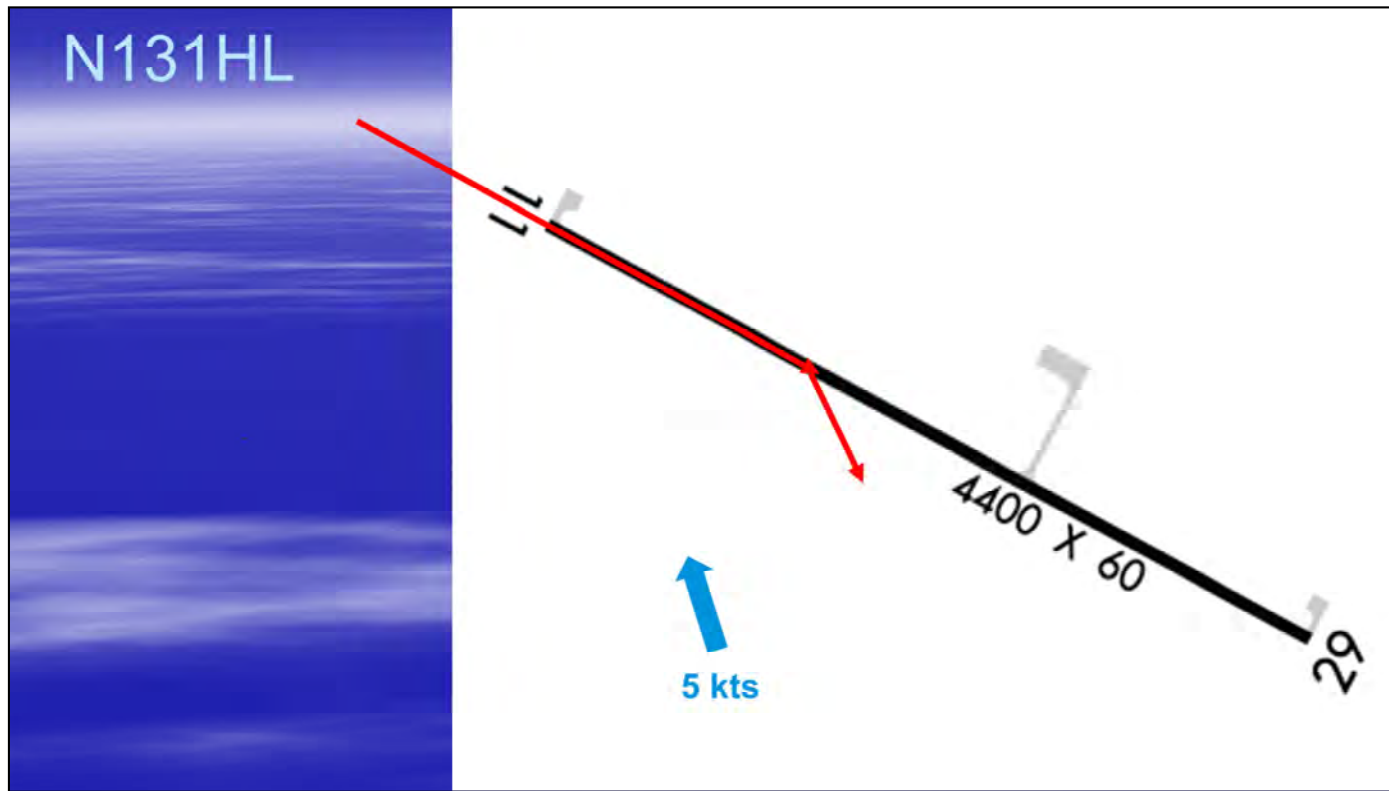
The pilot landed, presumably on 11, given the winds.

When the nose wheel touched down, the plane pulled right, and ran off the runway.

The gear collapsed, and there was significant left wing damage (which is why it's on the accident list).

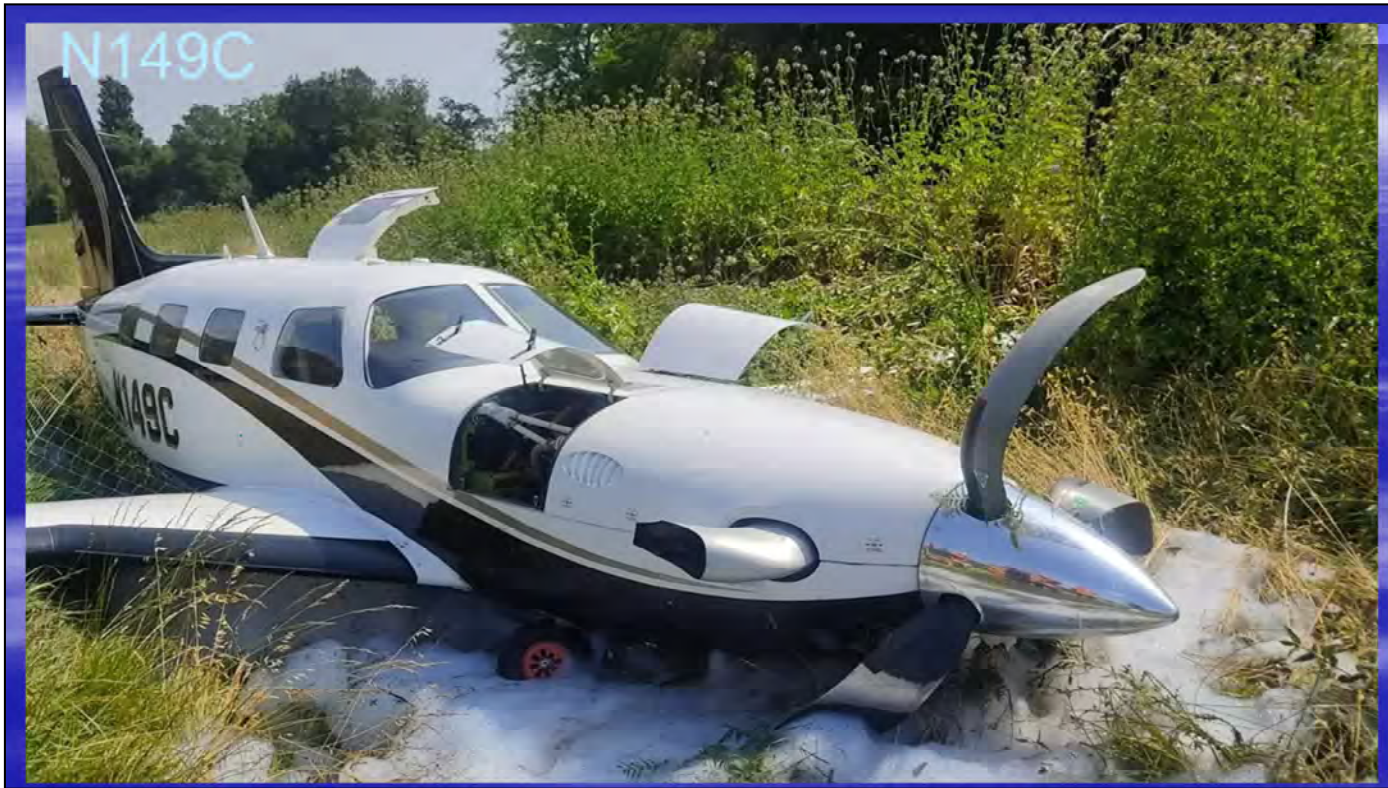
They overran the runway, hit a small fence, and the nose gear collapsed...

And once again, at this point, I have no information about what might have been the issue, if any, with the engine...

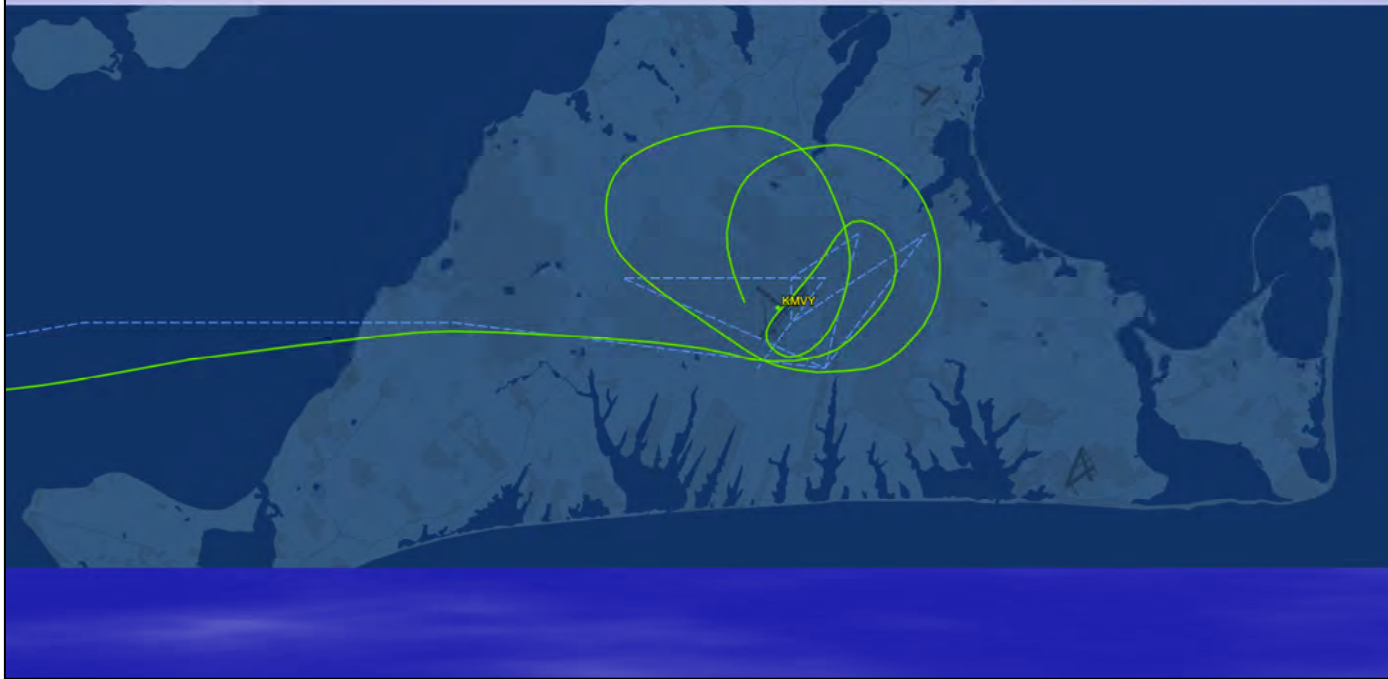
# N444RR

The 79-yr old pilot became incapacitated while on a missed approach, in good weather. His passenger said he “blacked out” and she took over the controls.

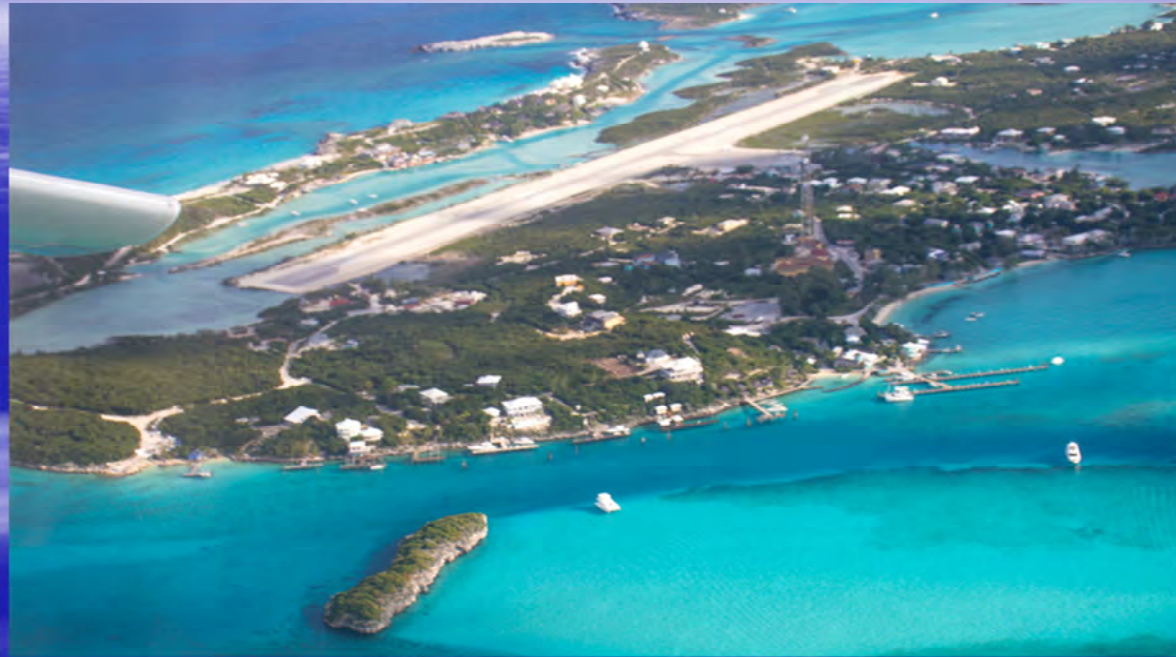
N4372L

According to the rather rudimentary Bahamas accident report, the pilot reported a wind gust right around touchdown, but an otherwise normal landing, and then 200 feet down the runway when the nose wheel touched down, the nose gear collapsed.

The nose gear actuator rod was bent 70 degrees. The Bahamas report implies this was the cause of the gear collapse, but that misses the question of why and how was the rod bent in the first place.

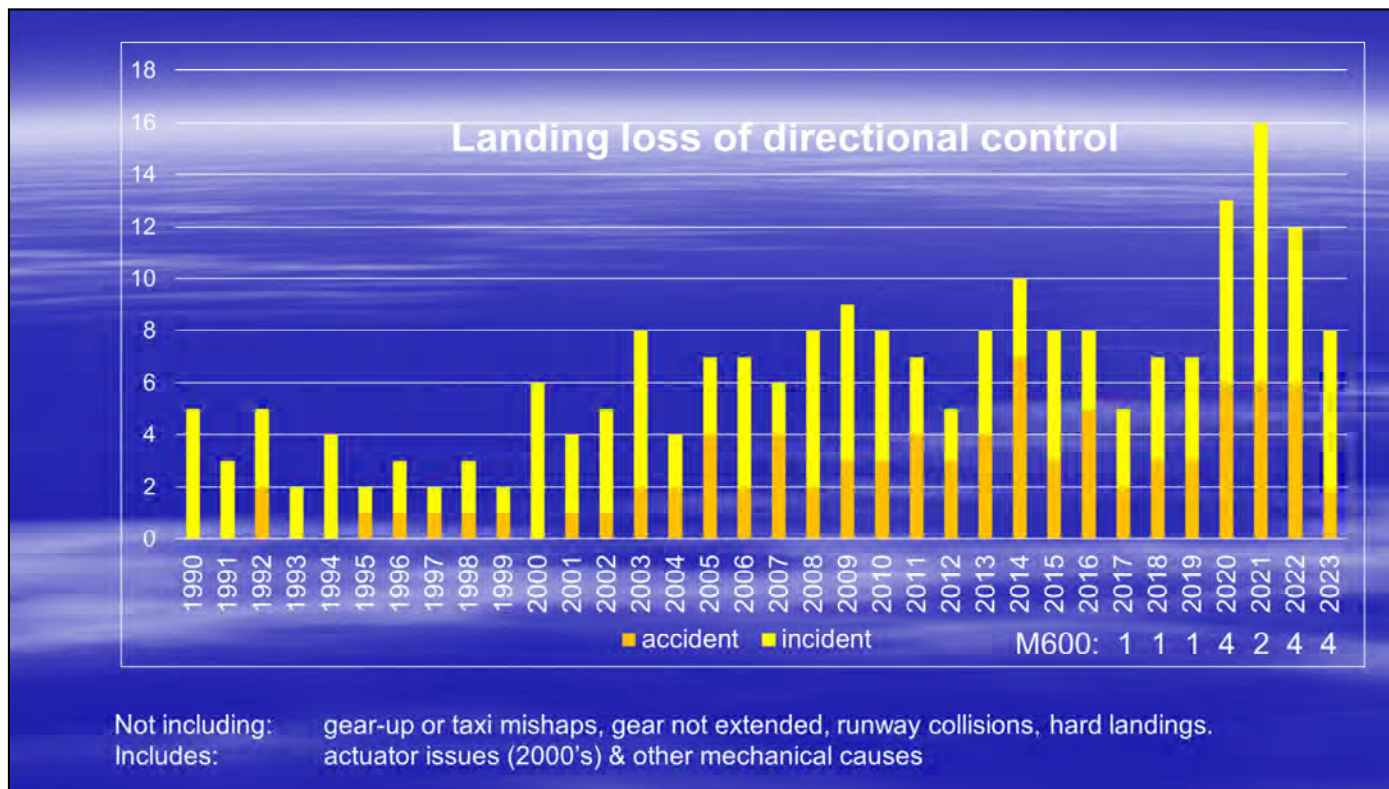
Here are landing excursions over the past 33 years. This chart presents raw annual counts.

You can see this landing control issue has been around as long as the PA46 itself...

Clearly the number of these occurrences have increased over time.

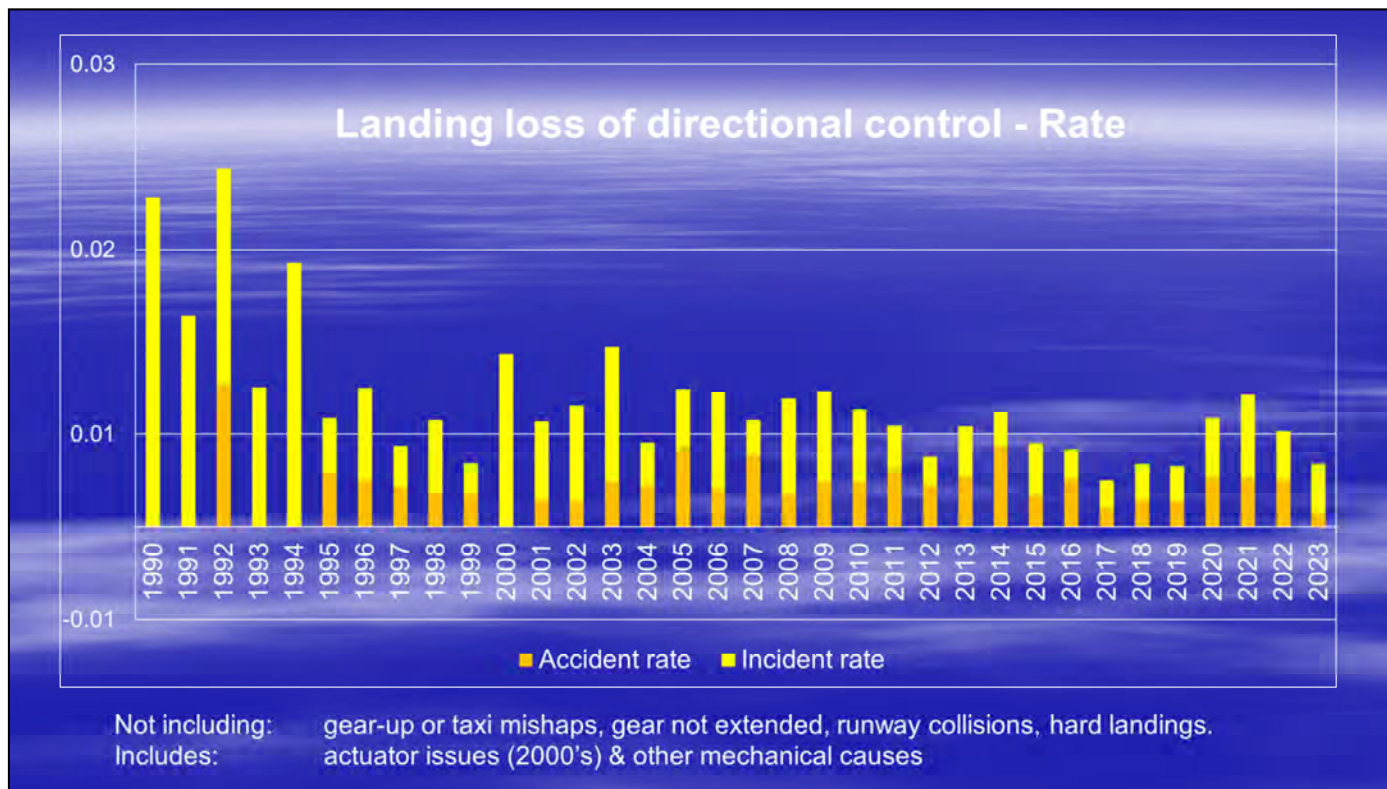
Here's exactly the same data, but presented as a **rate** of landing control issue per flying plane each year.

Looking at this, it's hard to make the case that things have changed much after the first 10 years of the PA46.
